GLENN DALE HOSPITAL HISTORIC DISTRICT

Field Observations Report

prepared for
M-NCPPC
Prince George's County
Department of Parks
& Recreation

June 8, 2015

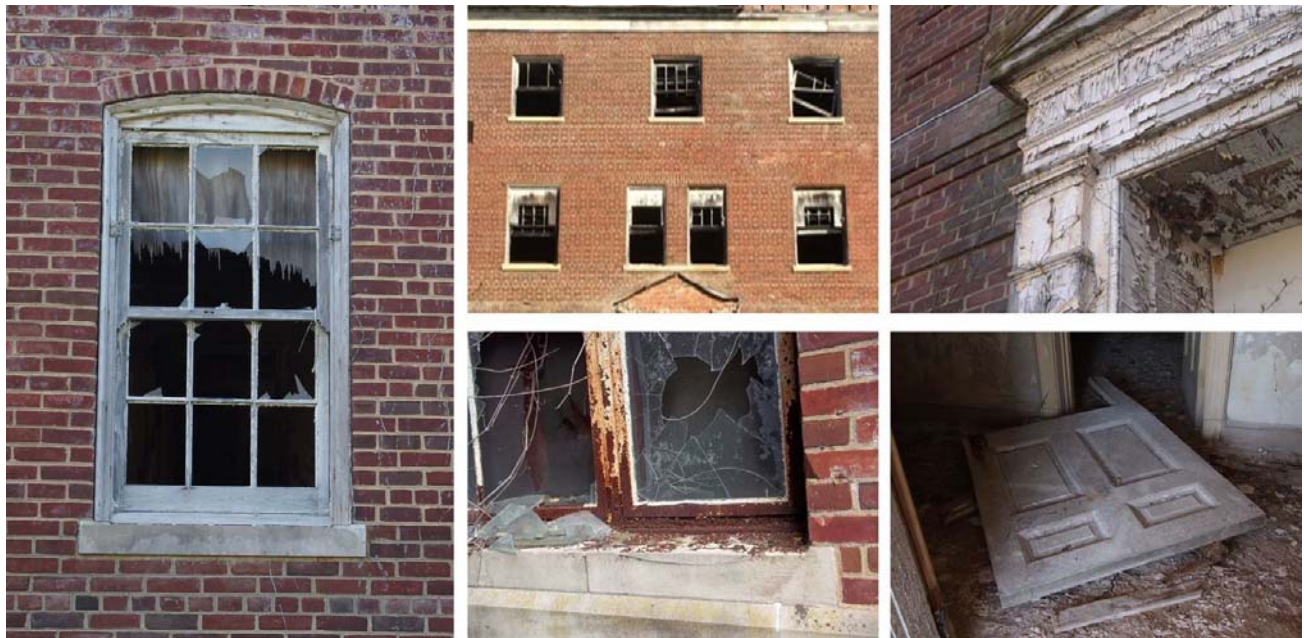
Most of the window glass has been broken and is not salvageable, though it appears that potentially, many of the wooden sashes, frames, and trim, and some of the metal casement windows remain in place. Many of the doors are missing, but many of the architectural elements remain, including door frames, trim, panel jambs and frontispieces. Continued exposure to the elements without adequate protection will hasten the decay of the wooden components.

- Most of the window glass has been broken.
- The wooden window frames and trim remain.
- The metal casement windows exhibit a high degree of corrosion.
- The stone sills and brick jack arches seem to be in good condition with minimal damage.
- Many doors have been removed, but they may be repairable if found within the buildings.
- Some doors are protected in place by metal gates.

Figure 4.1- 1 Various window and door conditions found at the Glenn Dale Hospital Historic District.

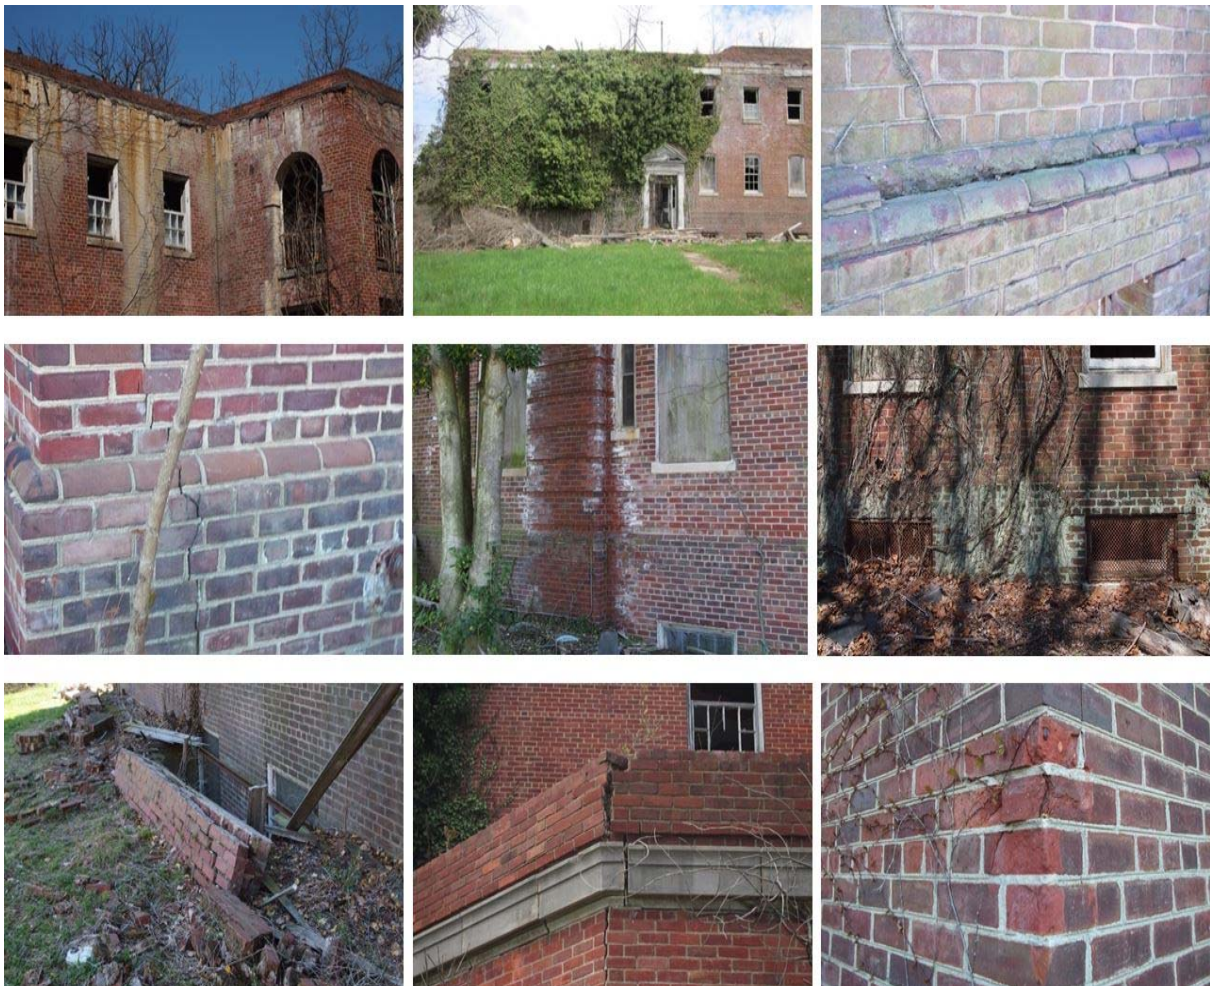
The masonry is in generally good condition, except for the damaged parapets on the Children's Hospital. There is a considerable amount of brickwork across the campus (nearly every building is brick-clad) that would need attention during a mothballing project. The wooden buildings and structures, and especially the porches, are in poor condition and may need to be tagged and disassembled to ensure their survival. Invasive vegetation covers many buildings and contributes to the deterioration of the brickwork and mortar.

- Invasive vegetation covers many of the buildings.
- There are signs of efflorescence and staining on the brickwork.
- Some limited cracking in the brick veneer was observed.
- Areas of organic growth including moss and algae were observed, mostly below the watertable or in shaded areas.
- Limited areas of damaged or spalling brickwork were observed.
- Most of the structural elements seem to be intact.
- Brick parapets have been almost completely removed from the Children's Hospital in an attempt to steal the metal flashing contained within.

Figure 4.1- 2 Various wall conditions found at the Glenn Dale Hospital Historic District.

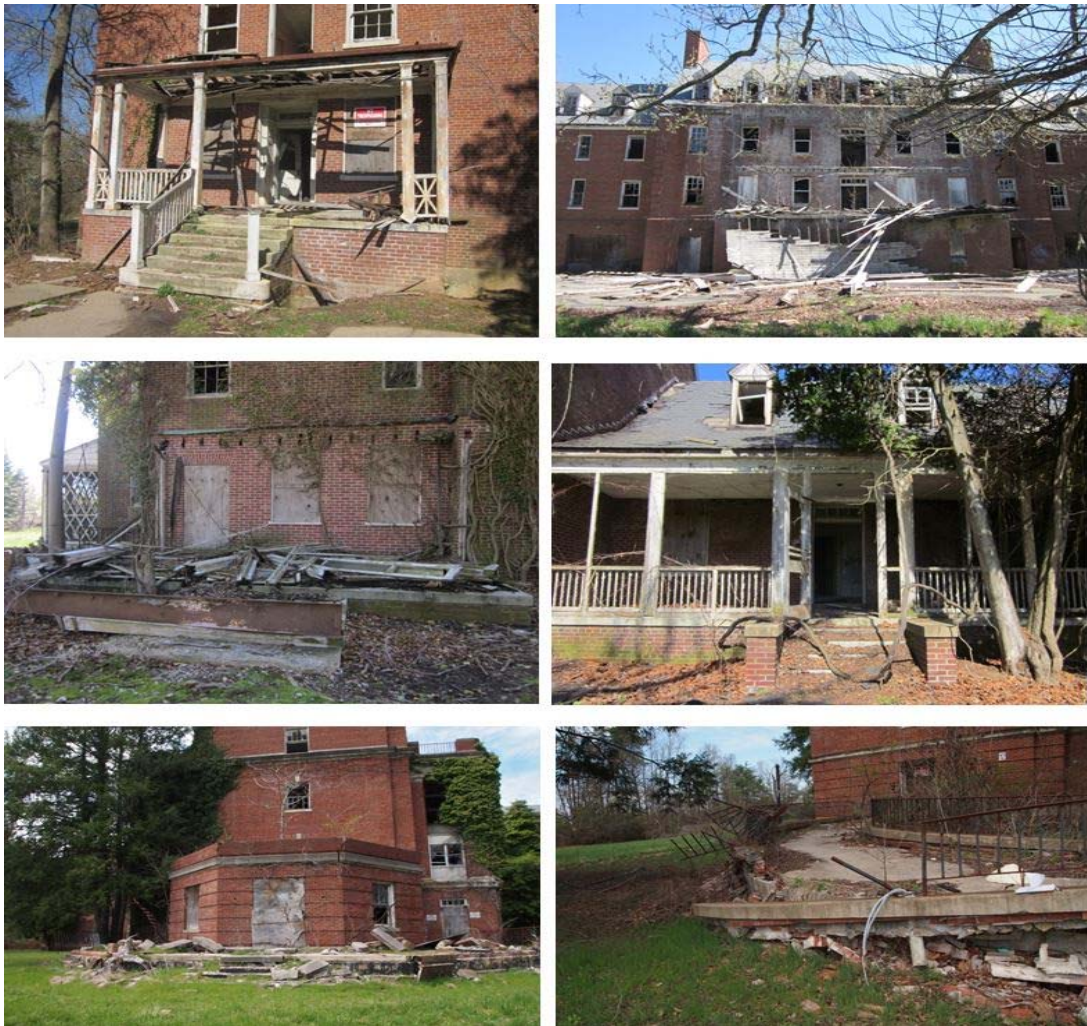
Most of the porches are in poor condition, especially those with wooden architectural elements. The rear porch on McCarren Hall has been lost. To ensure the further survival of the buildings and architectural elements from the porches, it may be necessary to tag and disassemble the wooden porches.

- The porch on the rear of McCarren Hall has completely collapsed, damaging the surrounding building fabric.
- The porches on the polygonal additions of the Adult Hospital wing are severely deteriorated, and may be beyond repair.
- The semi-circular ramp on the west end of the Adult Hospital is deteriorating quickly. The iron railings have been pulled apart and the brick facing is crumbling. The concrete sub-structure might be salvageable.
- The porches on Capper Hall have severe roof damage, allowing water infiltration to damage the wooden components.

Figure 4.1- 3 Various porch and railing conditions found at the Glenn Dale Hospital Historic District.

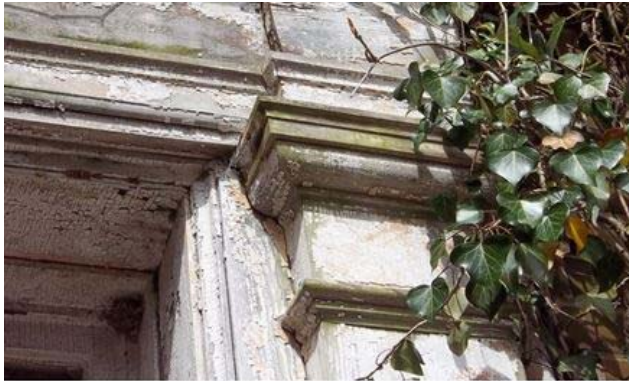
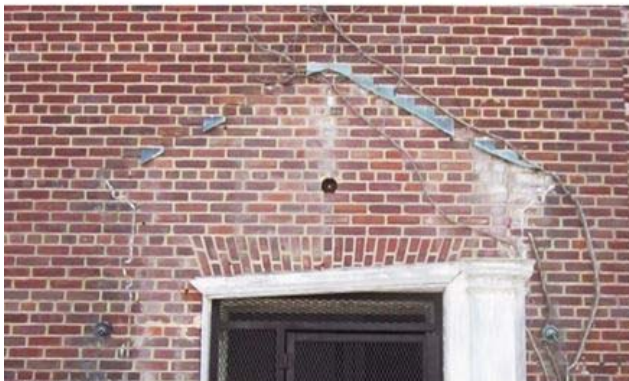
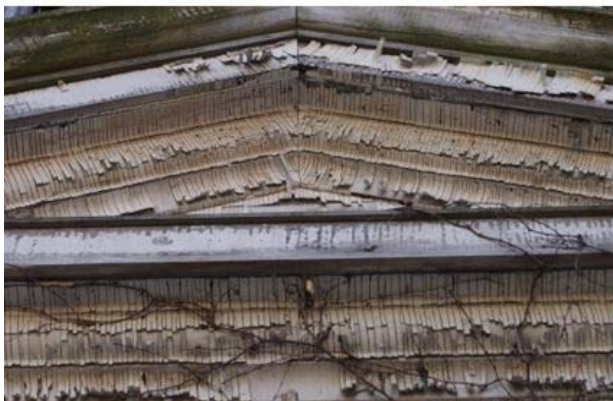
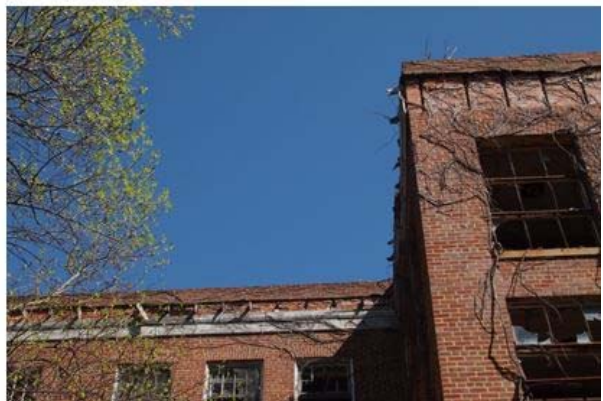
Despite being at the mercy of the elements, many of the wooden components appear to be in fair condition. In some cases, small elements may be missing such as plinth blocks. However, in rarer cases, entire assemblages are missing, such as the frontispiece on Capper Hall, and nearly all of the wooden exterior cornices.

- All exterior elements have flaking paint, significantly shortening the lifespan of unprotected wooden elements.
- Some elements are in poor condition, but could be repairable.
- Some components missing.
- Many of the wooden cornices on the buildings are beyond repair.

Figure 4.1- 4 Various woodwork conditions found at the Glenn Dale Hospital Historic District.

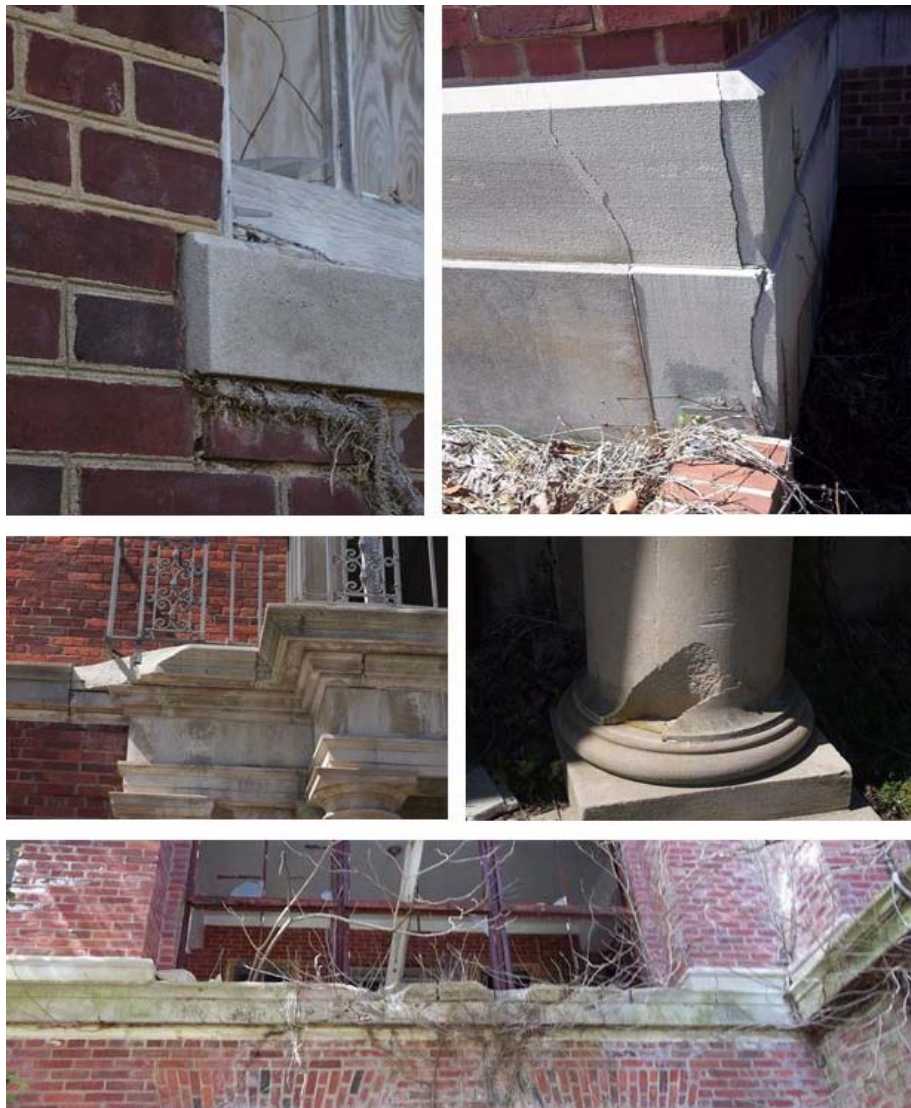
Most of the stonework is in good condition, especially the window sills and keystones. The areas with the most damage are all located on the Adult Hospital, where areas of spalling/cracking, chipping, and broken elements were observed.

- There are small sections of the stone frontispiece on the Adult Hospital that have chipped out. The areas are isolated and can be repaired.
- The parapet caps have been removed from Finucane Hall by thieves seeking to salvage the metal flashing, but they appear to have been carefully removed and placed on the roof of the building.
- Some areas of stone spalling were found, particularly near the foundation of the Adult Hospital.
- Isolated areas of the stone cornice and beltcourse of the Adult Hospital have chipped, but appear to be repairable.
- The stone window components, including sills and keystones, appear to be in good condition.

Figure 4.1- 5 Various stonework conditions found at the Glenn Dale Hospital Historic District.

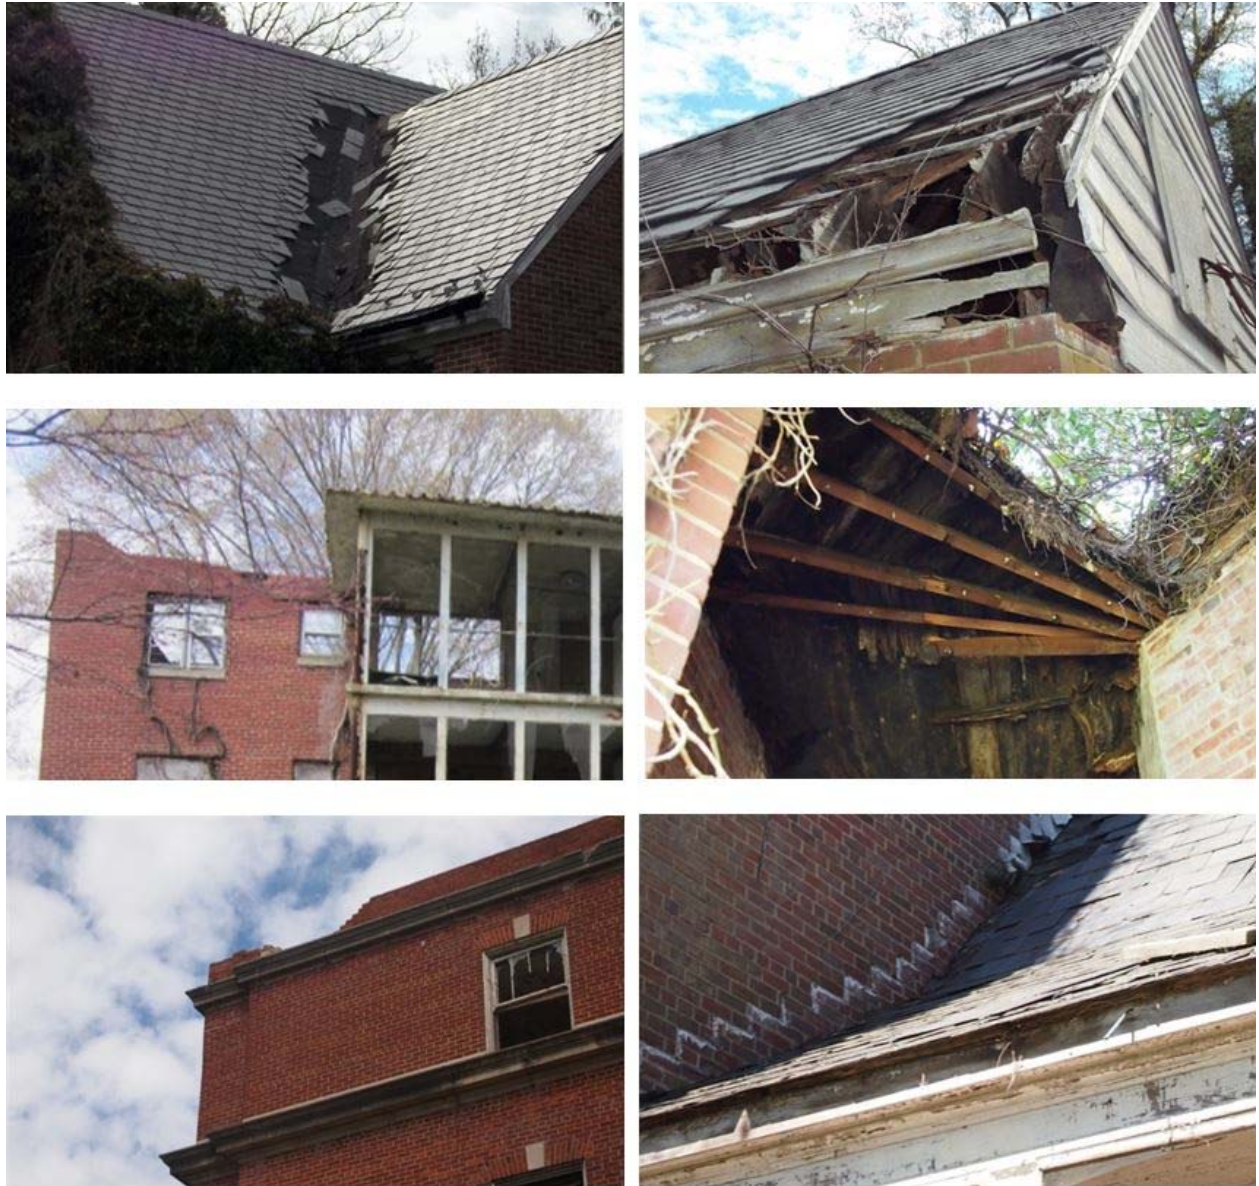
The roofs, especially the gable and pyramidal roofs, are the most vulnerable area of the buildings. The slates are disconnected, especially in the valleys and hips, where they were discarded by thieves to access the valuable flashing underneath. The flat roofs on the buildings have fared much better and are surprisingly intact, except for those on the Apartment Buildings, which appear to be fully collapsed. Many of the parapets have been lost or damaged, especially those on the Children's Hospital and Finucane Hall.

Figure 4.1- 6 Various roof conditions found at the Glenn Dale Hospital Historic District.

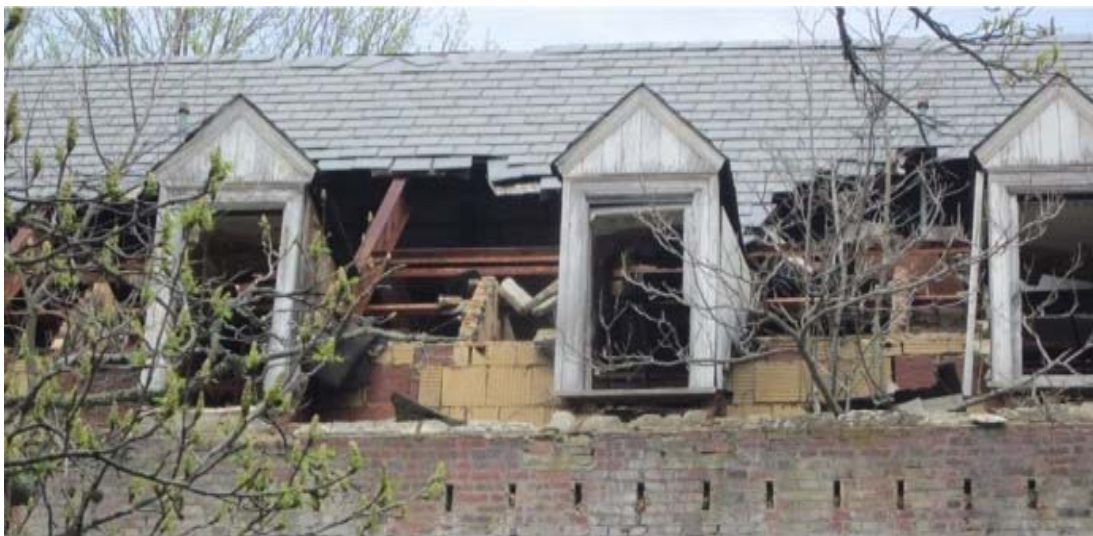
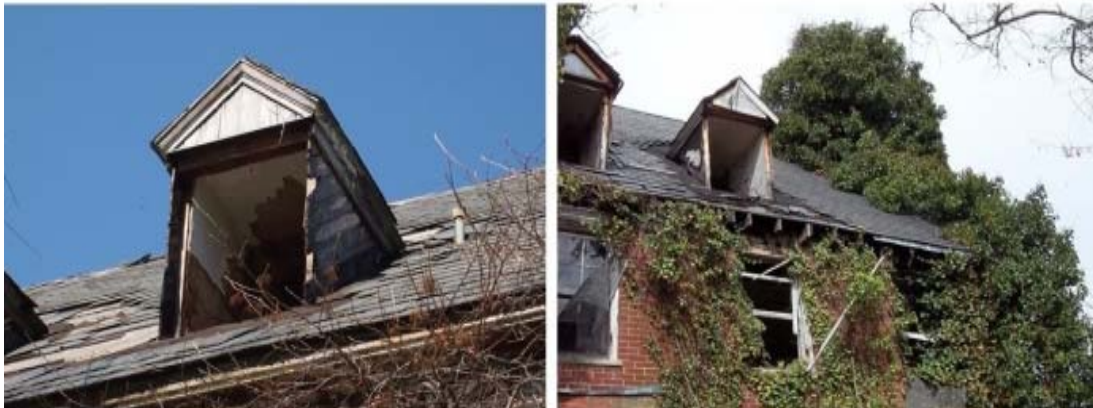
- Much of the copper flashing, rain gutters and leaders were removed by thieves, damaging surrounding material in the removal process.
- The wooden pergola structures on Gibson and Peabody Halls are in poor condition and will likely need to be removed.

- The slate on the gable roofs of Capper Hall, McCarren Hall, and the Duplexes has been damaged and continues to fall off the building. This is largely due to the extensive damage created when the step flashing was removed by thieves. Individual slates may be salvaged and reused.

- The flat roofs of the Apartment Buildings have completely collapsed. Survival of these buildings is questionable now that the roofs are gone, allowing water to infiltrate the building envelope.

- Although many of the dormers are in poor condition, the framing might be salvageable.
- When the porch on the back of McCarren Hall collapsed, a large opening was created where the porch pulled away from the roof. This is allowing water to infiltrate the building.

- The Arcade's flat roof has begun to collapse, endangering the historic fabric below.

Figure 4.1- 7 Various roof conditions found at the Glenn Dale Hospital Historic District.

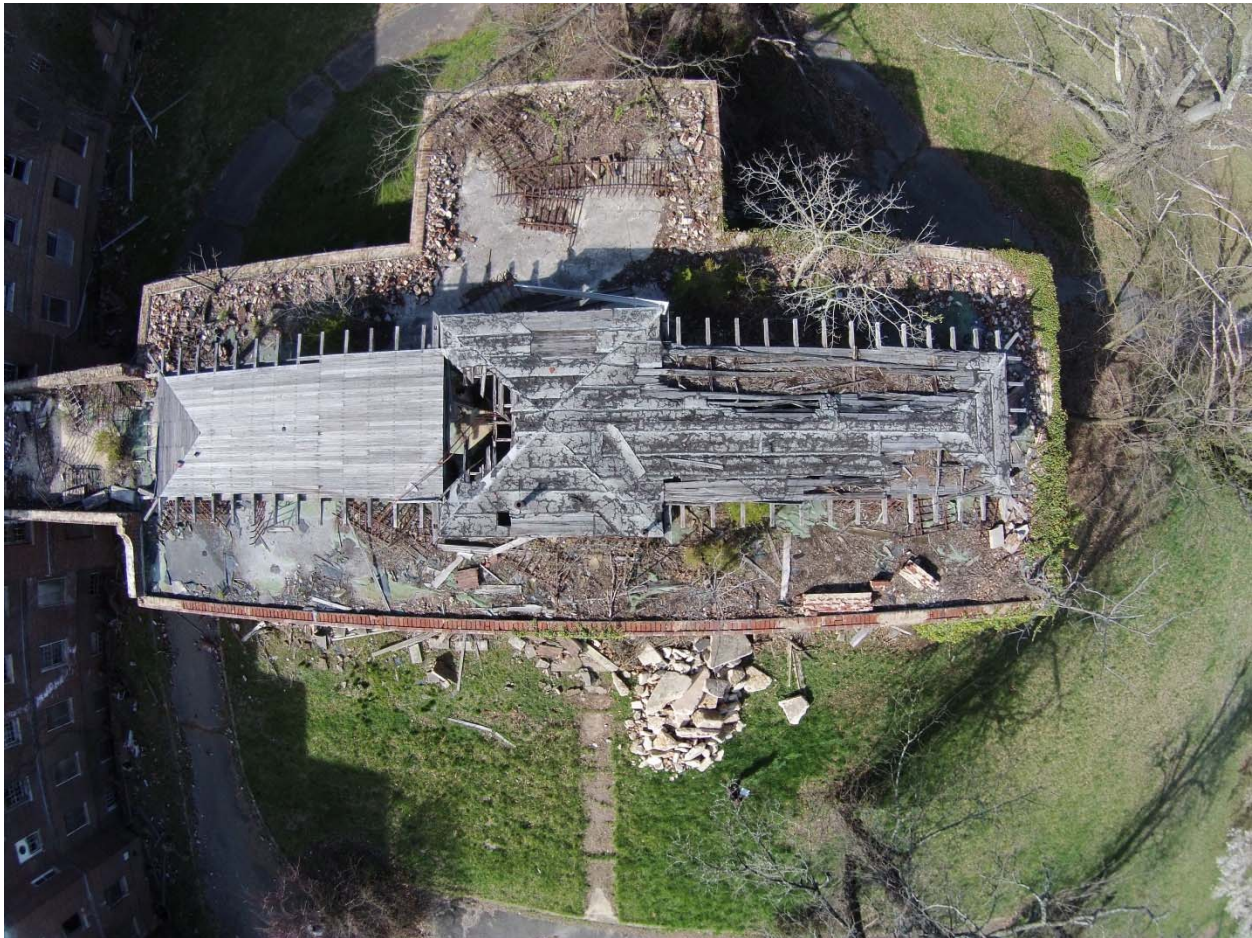
- The aerial survey revealed that the flat roofs are in much better condition than expected when observed from the at-grade survey. Issues include backed-up drains and debris, and wear to the remaining membrane and flashing. Several hatch covers are missing, allowing water to infiltrate the building.
- The extent of the damage to the valleys and hips on the gables and pyramidal roofs is evident. Entire sections of slate are missing where the copper flashing was stolen.
- The stone parapet caps on Finucane Hall are visible where they have been removed and placed on the flat roof, presumably to protect them.
- The extent of the parapet damage can be seen on the Children's Hospital, where entire sections of brick parapet have been damaged or removed.

Figure 4.1- 8 Aerial view of the roof of Gibson Hall.

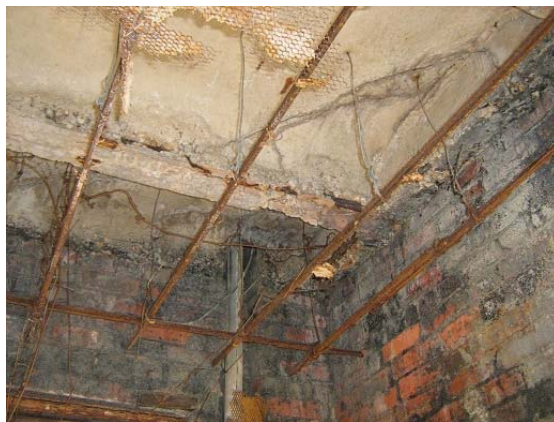
Isolated areas of corrosion of the reinforcing are evident at random locations but the extent of this damage does not appear to be widespread. Corrosion of the interior steel stairs is also evident. Treads have been lost in several of the runs.

Figure 4.2- 10: Concrete Reinforcing Corrosion

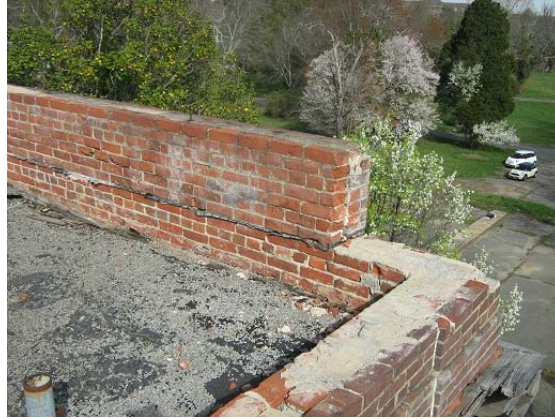
Figure 4.2- 13: Portion of Remaining Parapet

The single most distinctive structural damage to the Children's Hospital is the failure/destruction of the roof parapet. Most of the roof parapet has failed or has been removed by thieves above the fourth course of brick. The failure plane is consistent along the entire perimeter, which could be an indication that the parapet was "demolished" by thieves to remove the copper flashing evident in small areas of the remaining parapet.

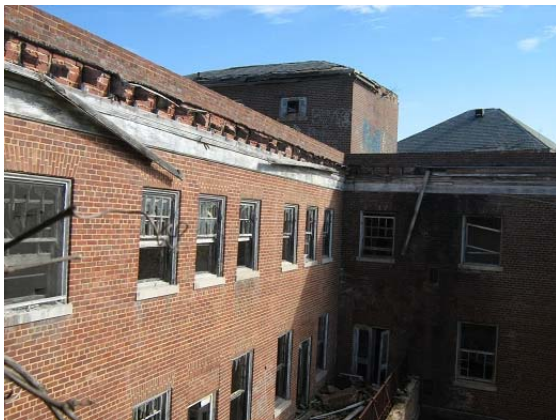
In many areas of the building, the parapet has fallen on one of the lower level balconies. We did not observe any significant structural damage of the soffit or the balcony slabs due to the impact of the fallen masonry. The loss of the parapet does not represent a loss of structural integrity of the building, but the loose brick and other materials should be removed to prevent damage from fallen debris.

Figure 4.2- 14: Rotted Wood Cornice and Fallen Parapet (Rear Elevation)

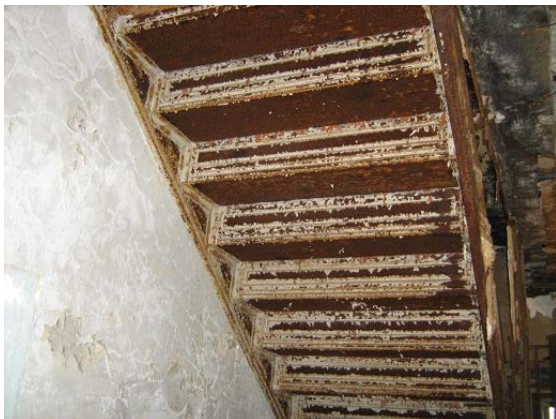
Figure 4.2- 20: Typical Corrosion on Metal Stairs

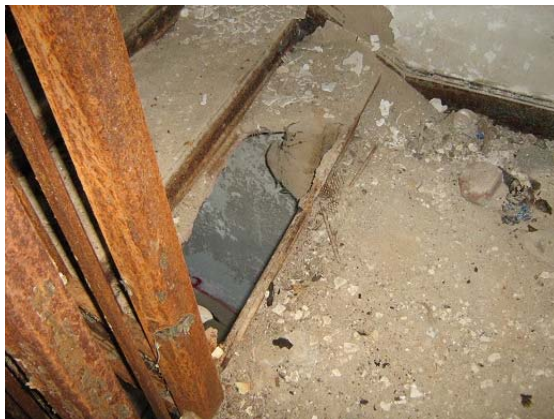
Figure 4.2- 21: Corroded Stair Tread

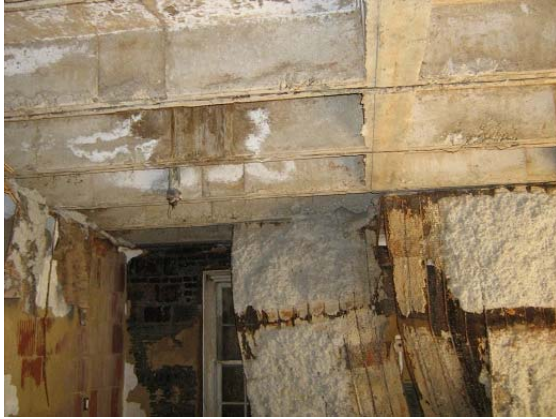
Figure 4.2- 26: Typical Concrete Floor Slab and Fallen Ceiling

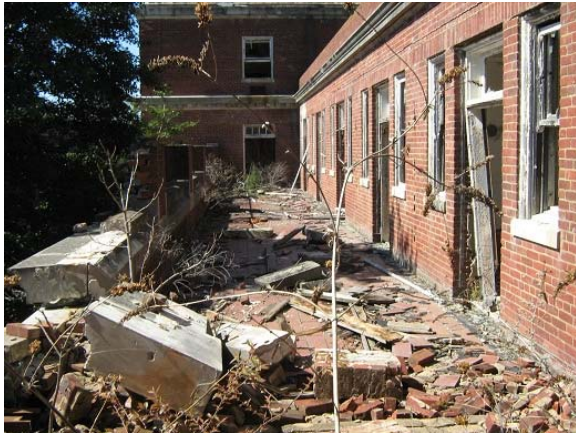
No significant structural damage was observed. Damage of isolated areas of the masonry parapet and the masonry at the expansion joints is evident. Several of the cast stone caps on the balconies have been removed and miscellaneous damage to the on-grade masonry walls was observed.

Figure 4.2- 28: Parapet Debris at Balcony

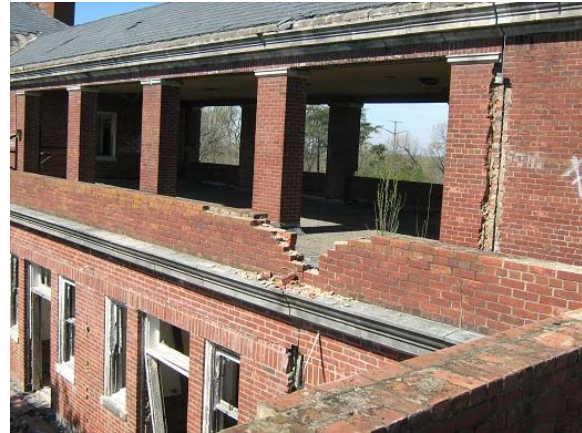
Figure 4.2- 29: Damaged Masonry at Expansion Joint

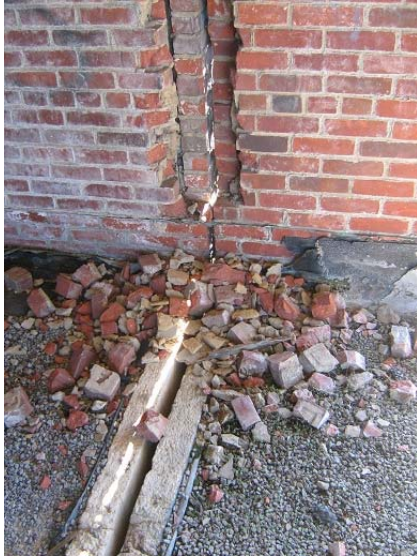
Figure 4.2- 30: Damaged Masonry at Expansion Joint

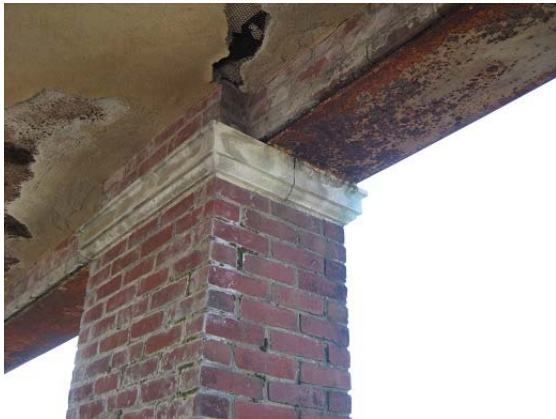
Figure 4.2- 31: Corrosion in Lintel

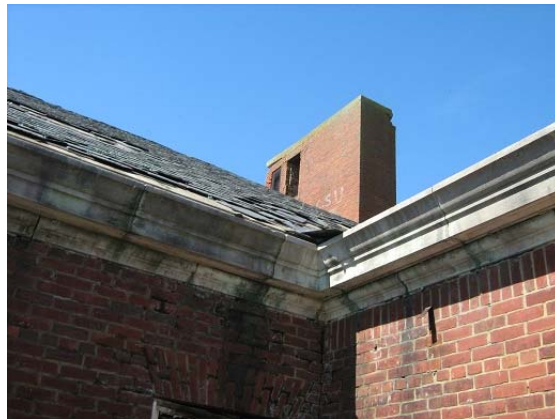
Figure 4.2- 32: Roof Cornice and Damaged Chimney

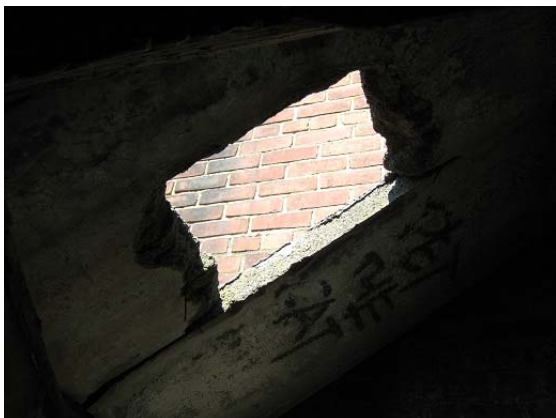
Figure 4.2- 33: Hole in Elevator Machine Room Roof

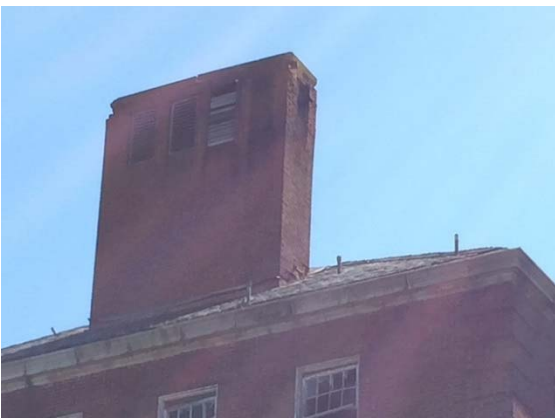
Figure 4.2- 34: Damaged Masonry in Chimney

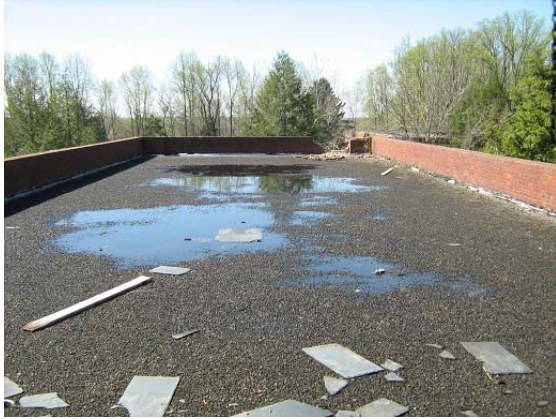
Figure 4.2- 35: Ponding Water at Roof

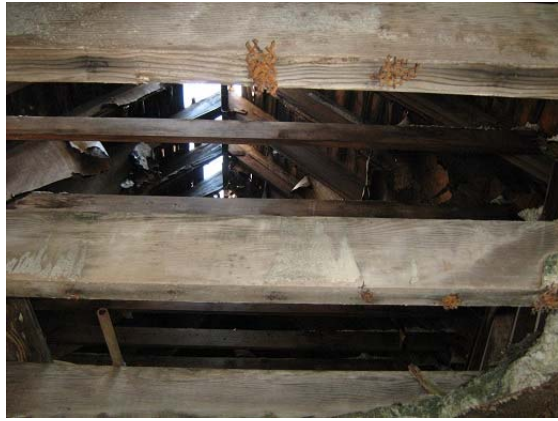
Figure 4.2- 43: Rotted Roof Rafters

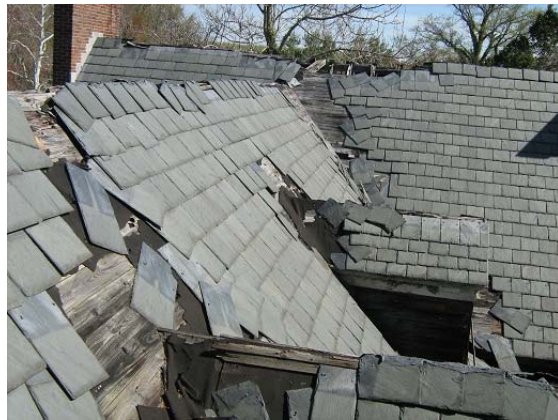
Figure 4.2- 45: Damaged Slate Roof

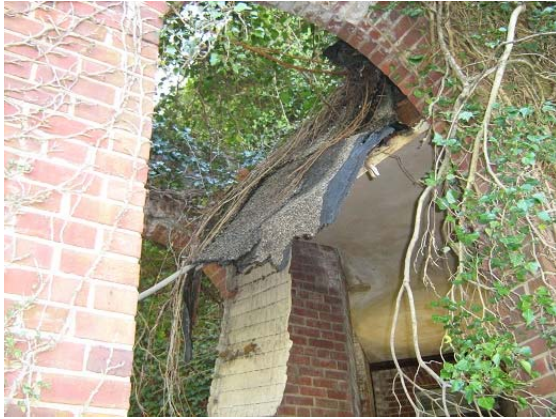
The connecting arcade framing consists of masonry walls and a wooden roof. A significant area of the wooden roof has failed due to water damage. If left unattended, further collapse of this roof will eliminate the top bracing of the arcade walls, which could lead to failure of these walls.

Figure 4.2- 46: Collapsed Arcade Roof

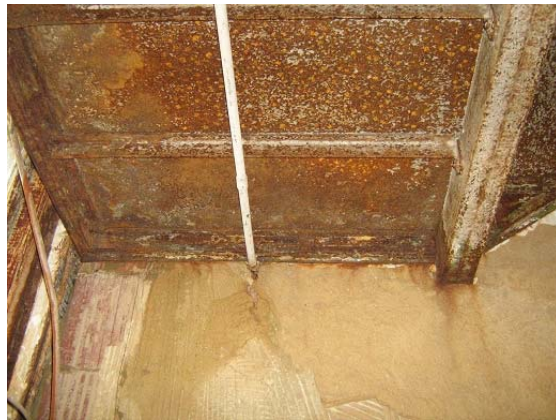
Figure 4.2- 55: Corrosion in Stair Landings

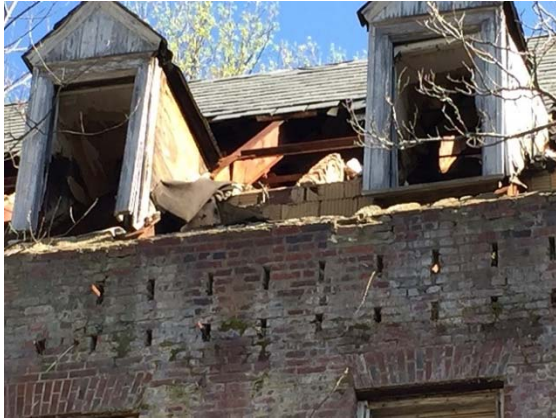
The roof framing for McCarren Hall consists of structural steel rafters that support steel purlins, which in turn support what appear to be lightweight concrete / clay roof panels and a slate roof. The roof has totally failed in many areas of the building.

Figure 4.2- 59: Collapsed Roof Rear Elevation

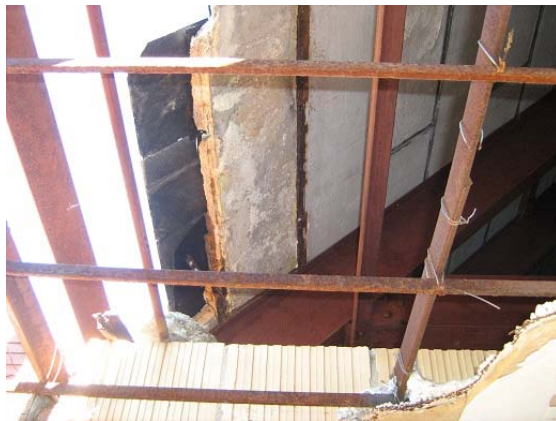
Figure 4.2- 62: Corroded Roof Purlin

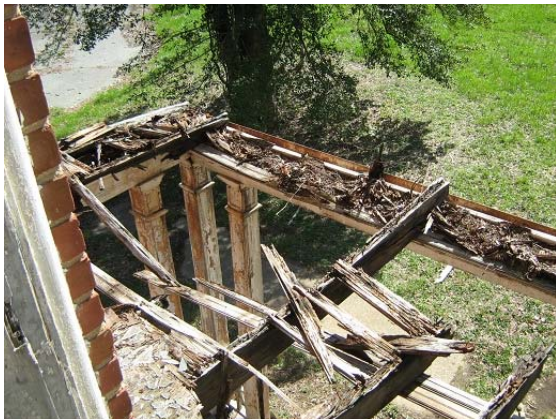
Figure 4.2- 63: Collapsed Rear Porch

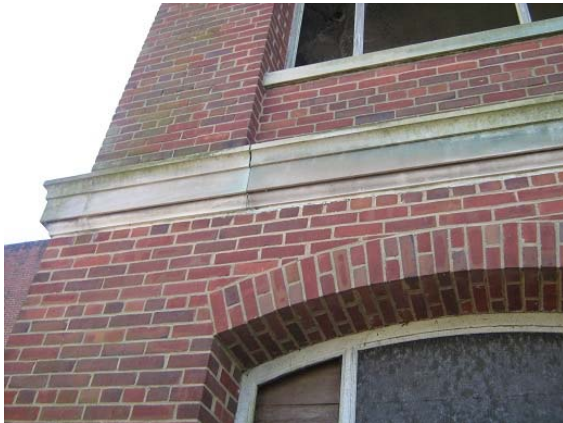
Figure 4.2- 70: Open Joint in Cornice

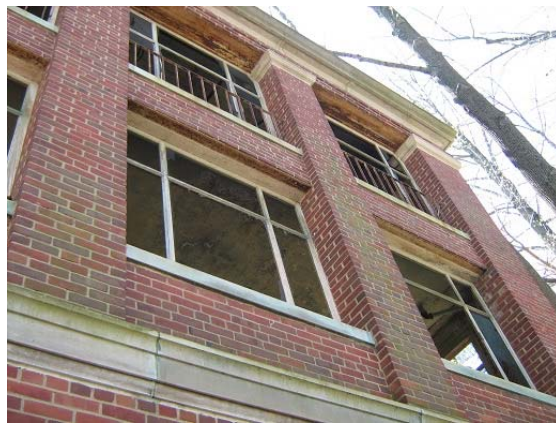
Figure 4.2- 71: Corrosion in Window Lintels

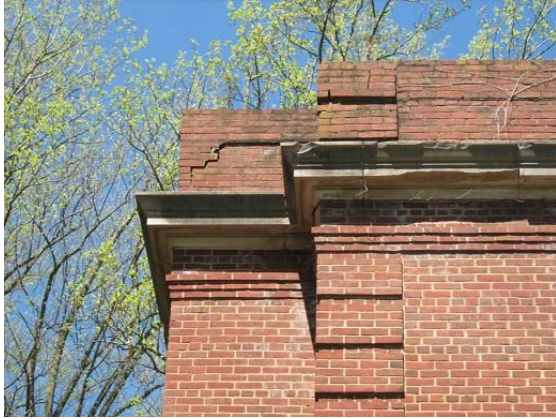
No significant structural damage was observed. Cracking of the masonry at some of the roof parapets is evident. The cast stone cap of the parapet has been removed along the entire perimeter. Significant areas of standing water are visible at the basement level and corrosion of the steel stairs is also evident. Treads have been lost in several of the runs.

Figure 4.2- 72: Cracked Parapet

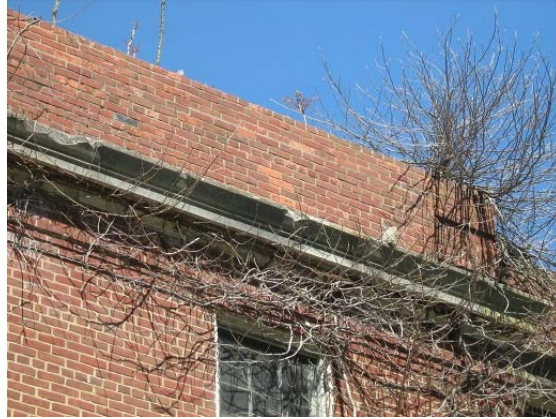
Figure 4.2- 73: Cracked Cornice

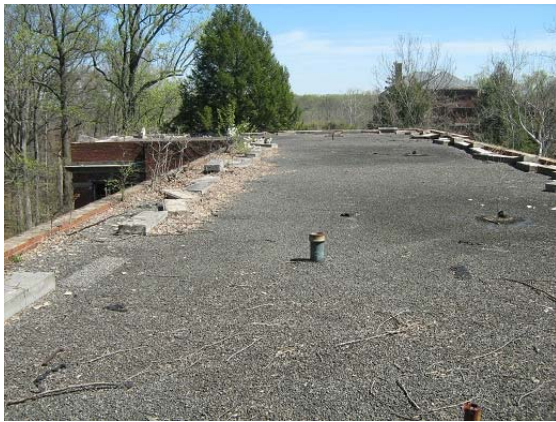
Figure 4.2- 74: Roof with Cap Stones Removed

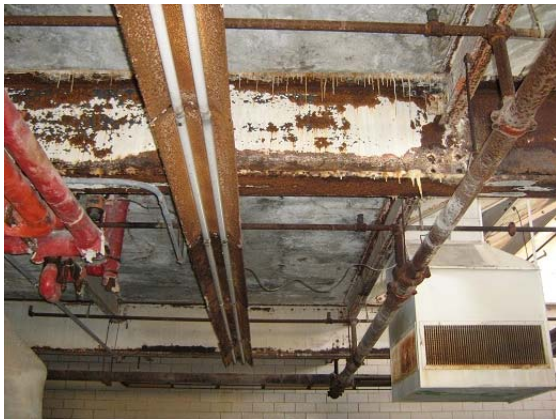
The structure for this building appears to consist of a concrete slab supported on a structural steel frame. The condition of the structure is fair. Widespread corrosion of the structural steel beams, columns and girders is evident. Standing water is visible on the slab on grade.

Figure 4.2- 85: Typical Corrosion in Laundry Building Framing

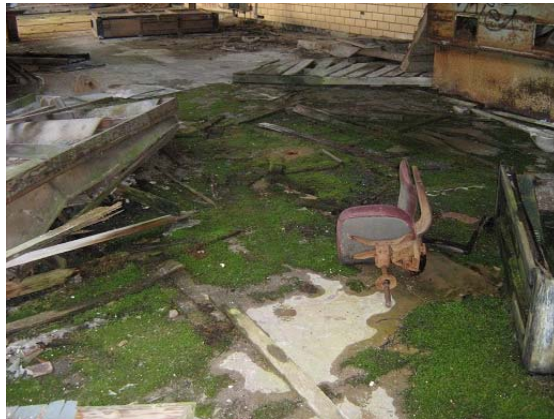
Figure 4.2- 86: Water and Mold on Laundry Slab on Grade

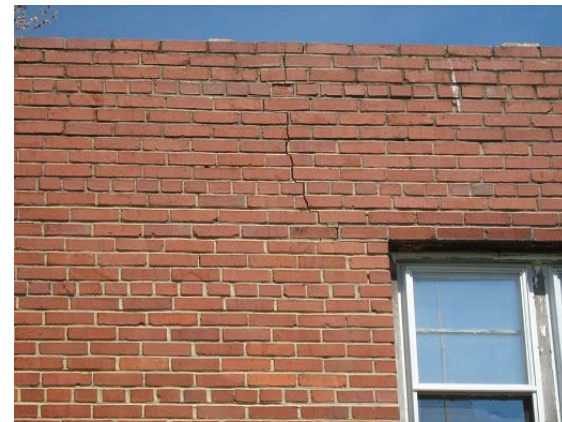
The structures for both these buildings are in bad condition due to the partial collapse of the roof. In a few areas, the perimeter façade is cracking and at risk of falling.

Figure 4.2- 96: Apartment 1 - Cracks in Masonry Facade Due to Collapse

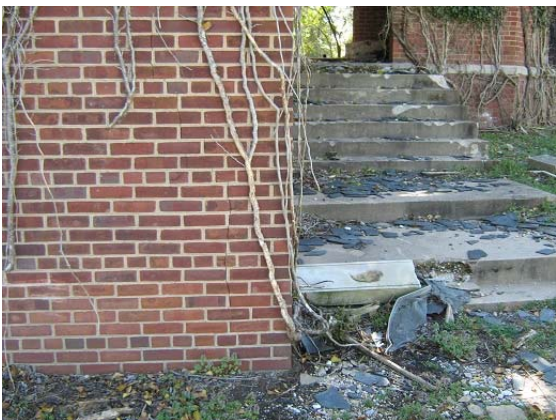
Figure 4.2- 103: West Duplex Masonry Crack

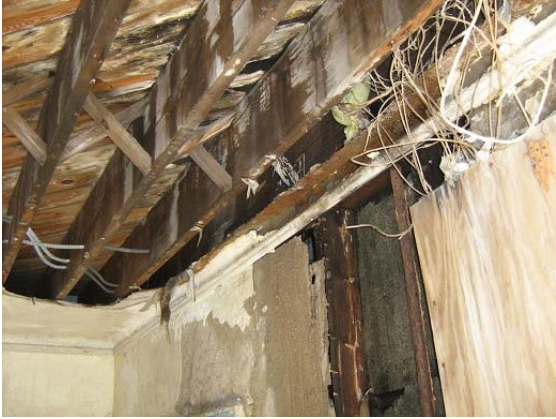
The structures for both these two small houses are in fair condition. The floor decking has areas where it has rotted, making any interior observations unsafe. Water damage is evident in portions of the roof.

Figure 4.2- 105: West Duplex - Water Damage in Floor Framing

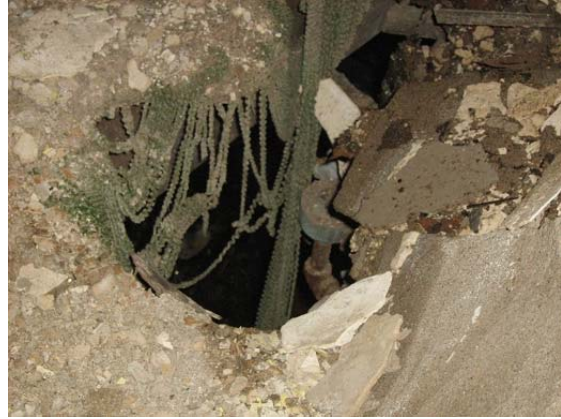
Figure 4.2- 106: East Duplex - Collapsed Floor Decking

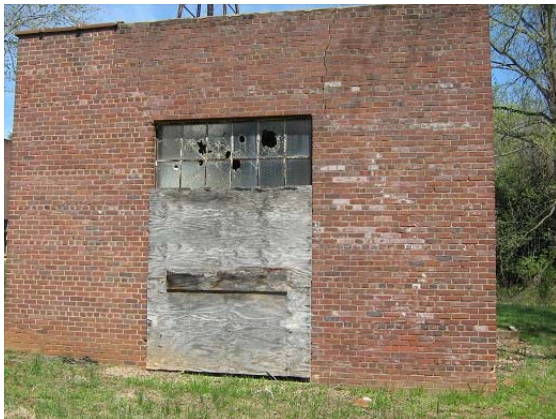
Figure 4.2- 115: Water Softener House: Side Elevation
-Crack in Masonry Due to Roof Collapse

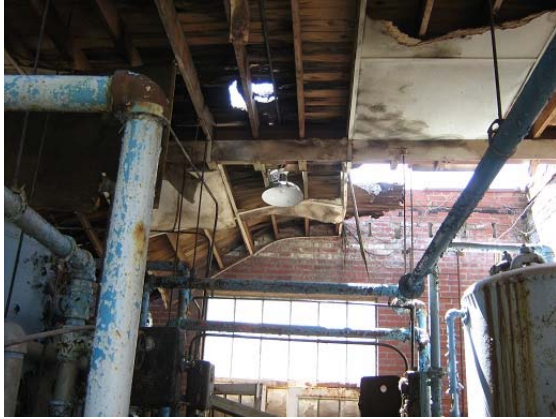
The structures for both these buildings are in bad condition due to the partial collapse of the roofs. In a few areas, the perimeter façade is cracking and at risk of falling.

Figure 4.2- 119: Water Softener House - Moisture in Roof Joists - Holes in Roof

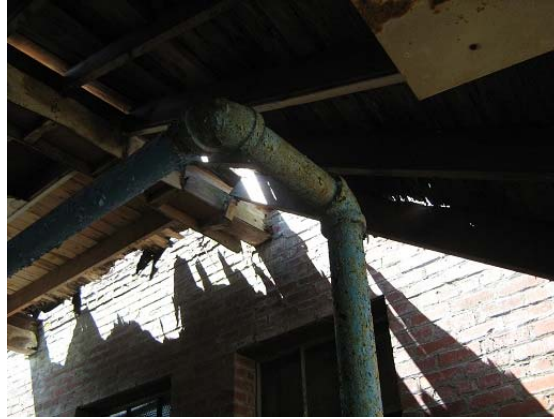
Figure 4.2- 120: Water Softener House - Collapsed Roof

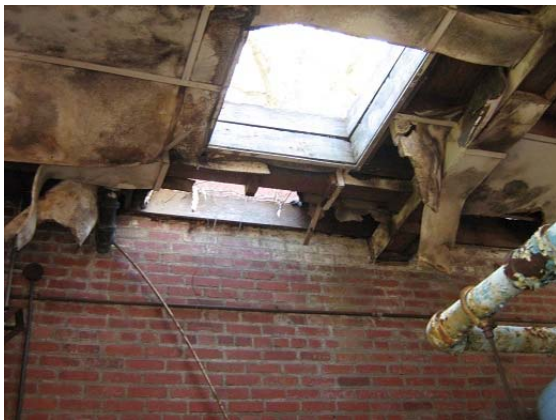
Figure 4.2- 121: Water Softener House - Moisture in Roof

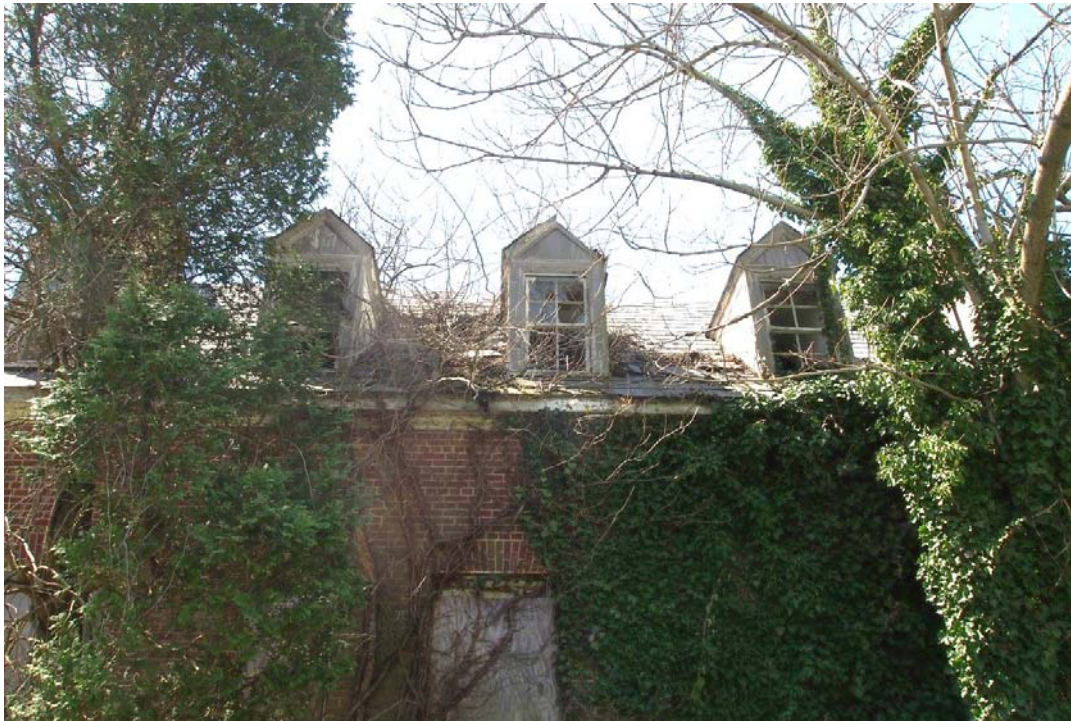
Figure 5.5- 1 Excessive vegetation and invasive vines cover one end of Capper Hall.

Lawns should be mowed frequently during the growing season. Any dead or damaged trees should also be removed, especially those in close proximity to the buildings that could damage the buildings if they fell during a storm. An arborist can be consulted to note damaged or diseased trees that should be culled.
