**PHASE I ENVIRONMENTAL ASSESSMENT
GLENN DALE HOSPITAL
5201 GLENN DALE ROAD
GLENN DALE, MARYLAND 20769**

**THE MARYLAND-NATIONAL CAPITAL
PARK AND PLANNING COMMISSION
6600 KENILWORTH AVENUE
RIVERDALE, MARYLAND 20737**

**PMT & ASSOCIATES, INC.
73 WEST TIMONIUM ROAD
TIMONIUM, MARYLAND 21093**

**FEBRUARY 10, 1994
PMT PROJECT: 94-23-02**

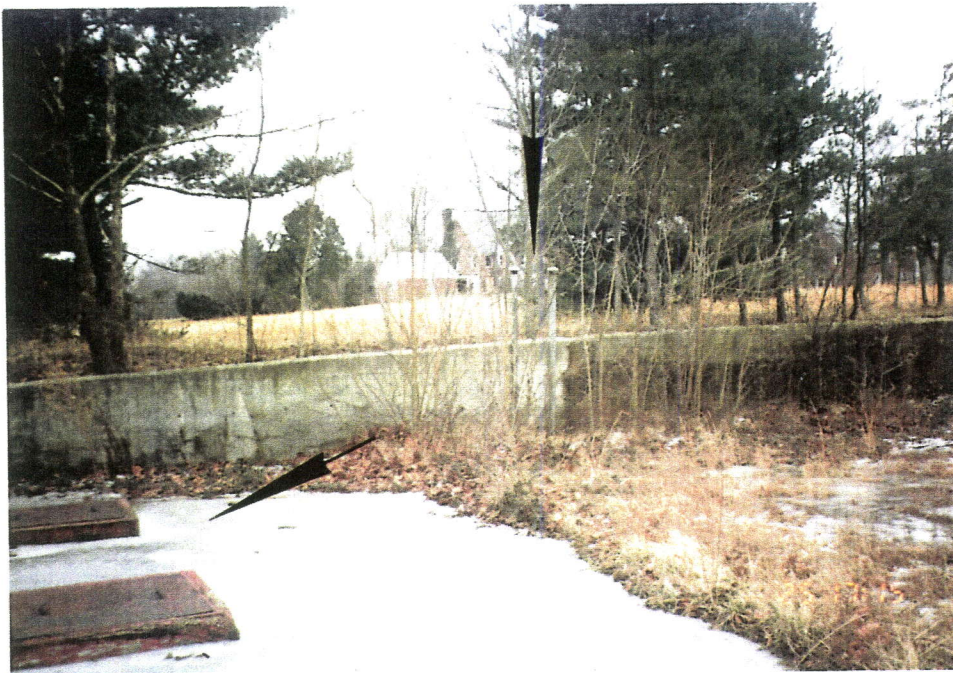
Photo 1: Two Vent Pipes For The Large USTs (Arrows Indicate Pipes And Manways).

→ PMT recommends the underground storage tanks and their associated piping be properly removed from the site. This would include observations for, and removal of, any visibly contaminated soils, soil sampling for laboratory confirmation, and the appropriate backfilling of the excavations. Maryland regulations require tanks that have been out of service greater than 180 days to be removed and properly disposed.

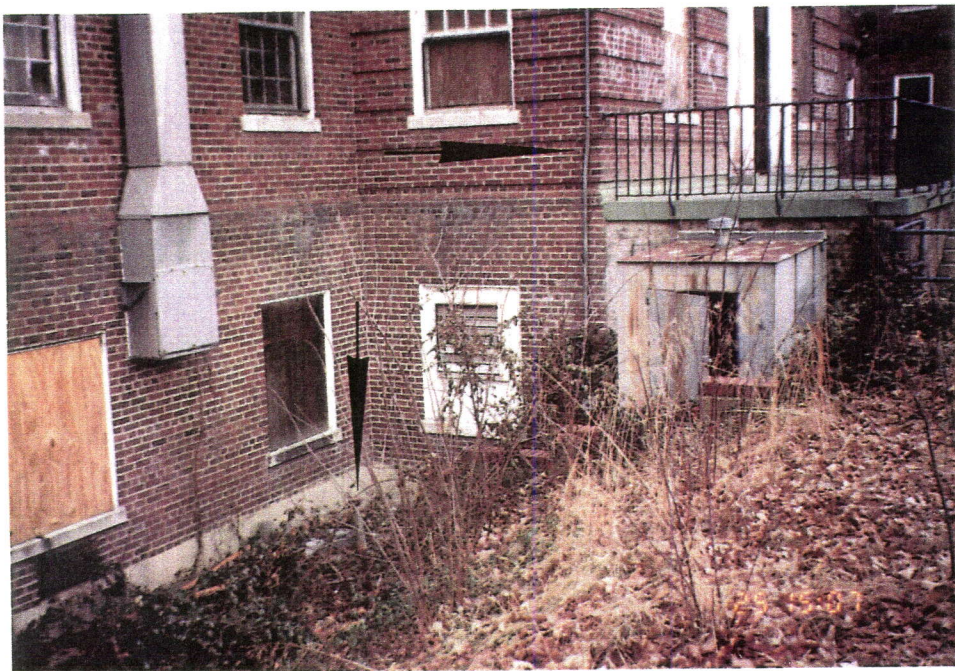
Photo 2: Tank Location In Back Of Children's Hospital Building (Arrows Denote Fill And Vent Pipes).

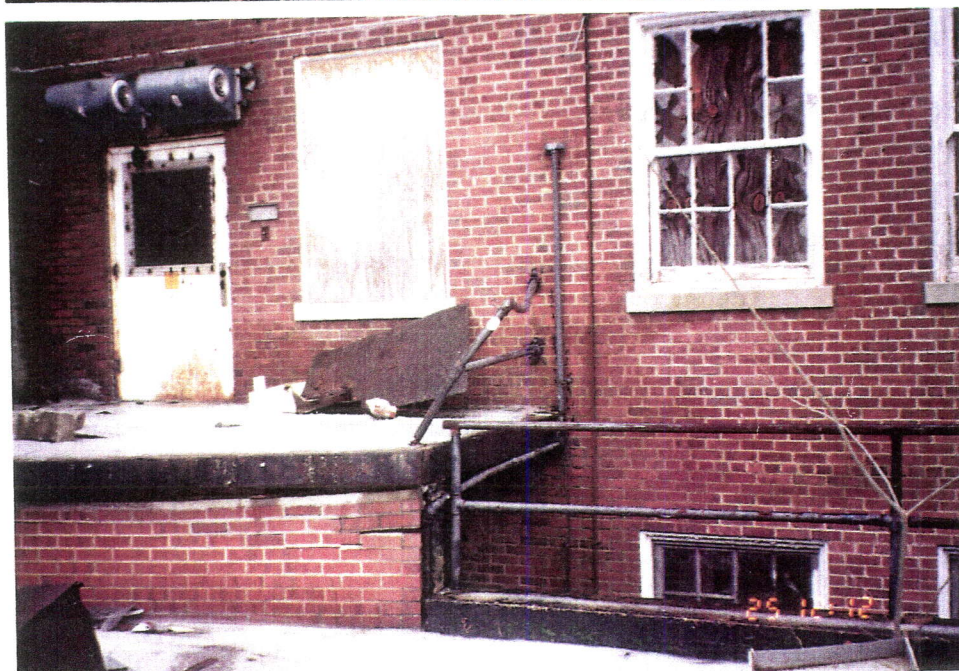
Photo 3: Tank Location In Back Of Adult Hospital.

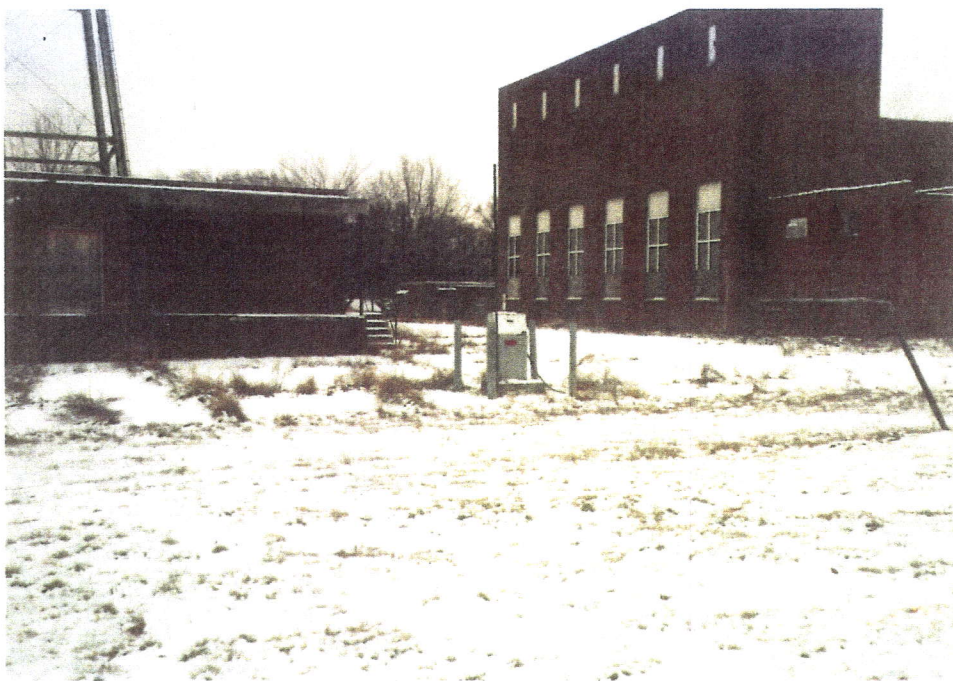
Photo 4: Vent Pipe
And Pad-Mounted
Dispenser Near
Utility Building.

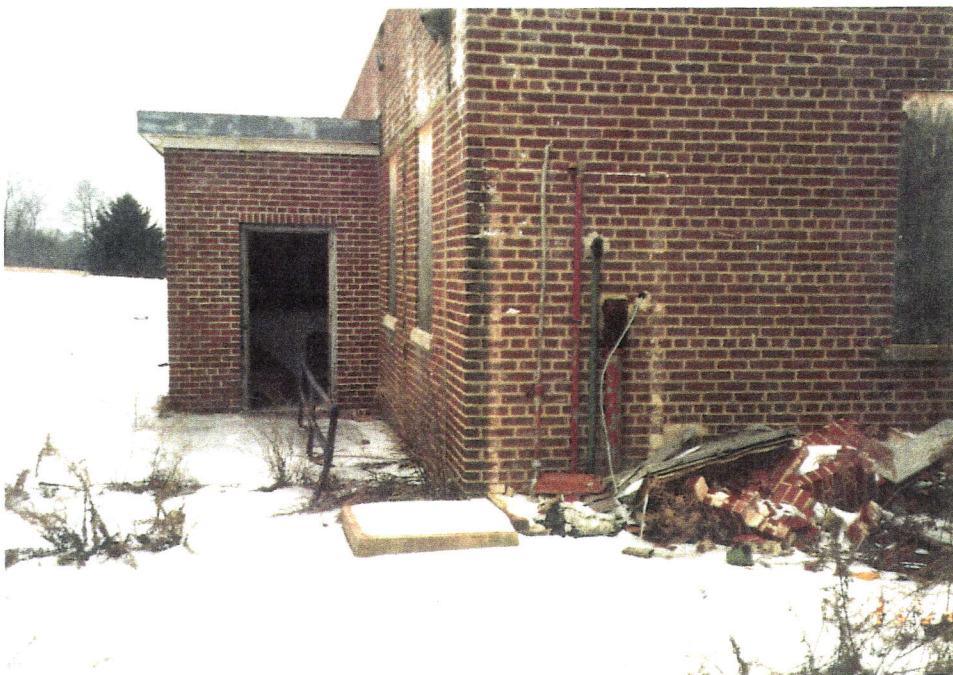
Photo 5: Vent Pipe
Location On The
East Side Of Utility
Building.

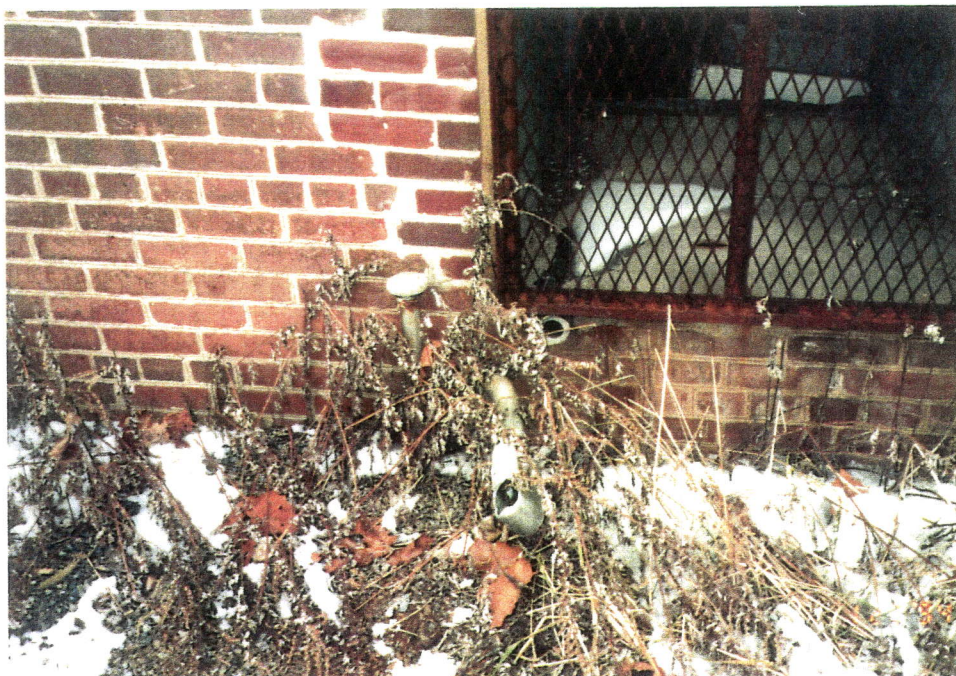
Photo 6: Vent Pipe
Location East Side
Of Power Plant.

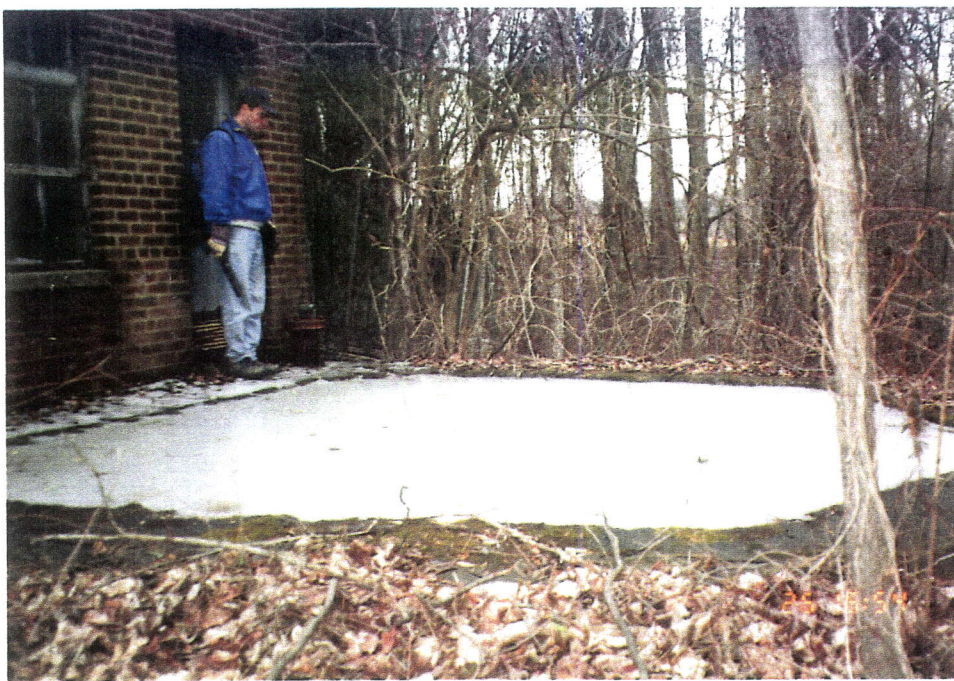
One (1) tank is an open topped, sedimentation control tank (thought to be 25,000-gallon or larger) located at the sedimentation control building on the eastern side of the property (Photo 7). This tank was used in connection with the sewage disposal system. It is currently filled with water. The remaining manways and caps observed were for site services (i.e., domestic water, storm water, electric, and sanitary sewer, and steam system).

Photo 7: Open Top
Of The Sediment
Control Tank.

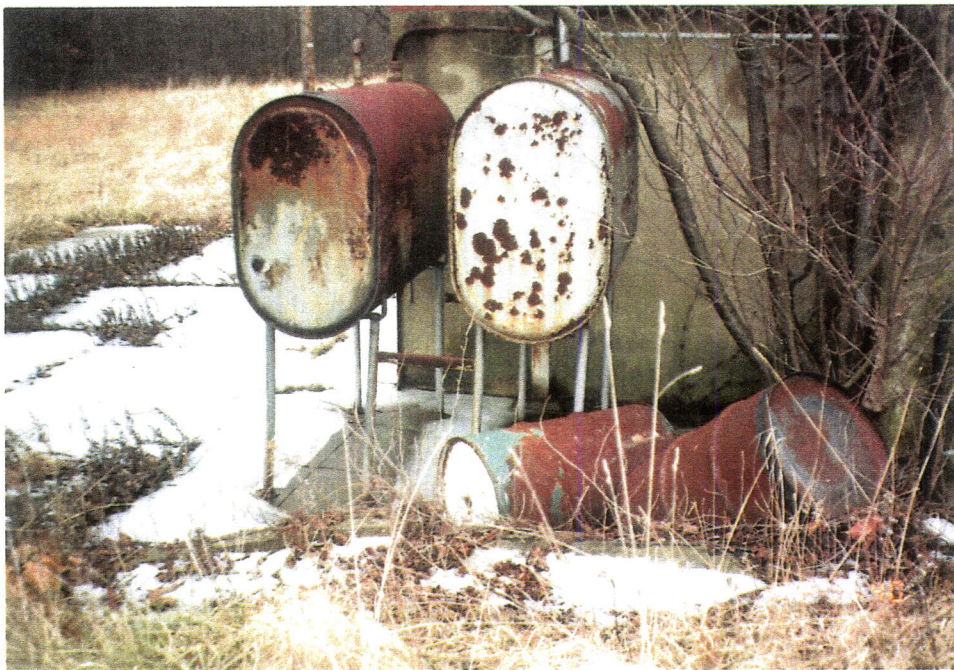
In addition, four (4) aboveground storage tanks were observed. Two (2) of the tanks were utilized as a fuel source for the incinerator operation (Photo 8). One (1) tank was abandoned on the western side of the adult hospital (Photo 9). One (1) dip tank, observed to be empty, is located on the northwestern side of the paint shop (Photo 10).

Photo 8: Two
Tanks Associated
With The
Incinerator.

PMT recommends that these aboveground tanks also be removed from the site. There was no visible signs of contamination around these tanks. Soil borings should be performed in the areas around and under these tanks to determine the presence or

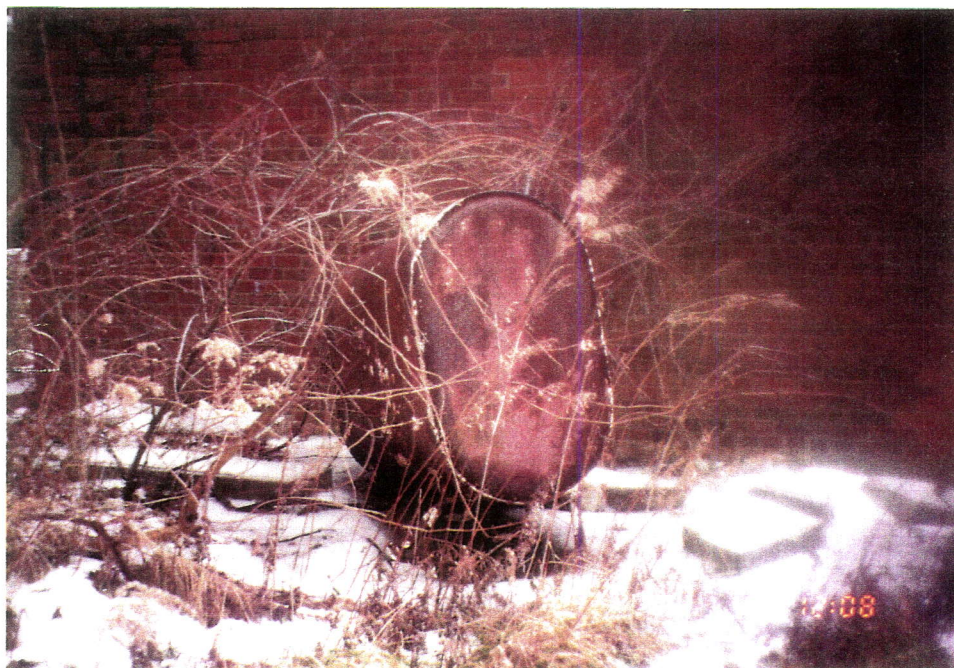
Photo 9:
Abandoned Tank
Behind Adult
Hospital Building.

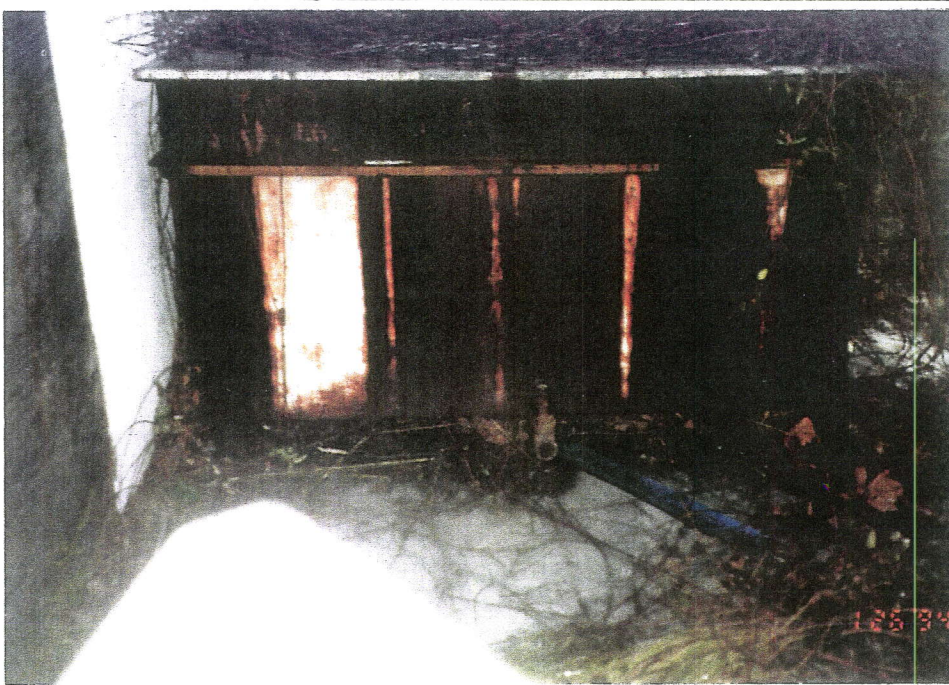
Photo 10: Dip
Tank On The
Northwest Side Of
The Paint Shop.

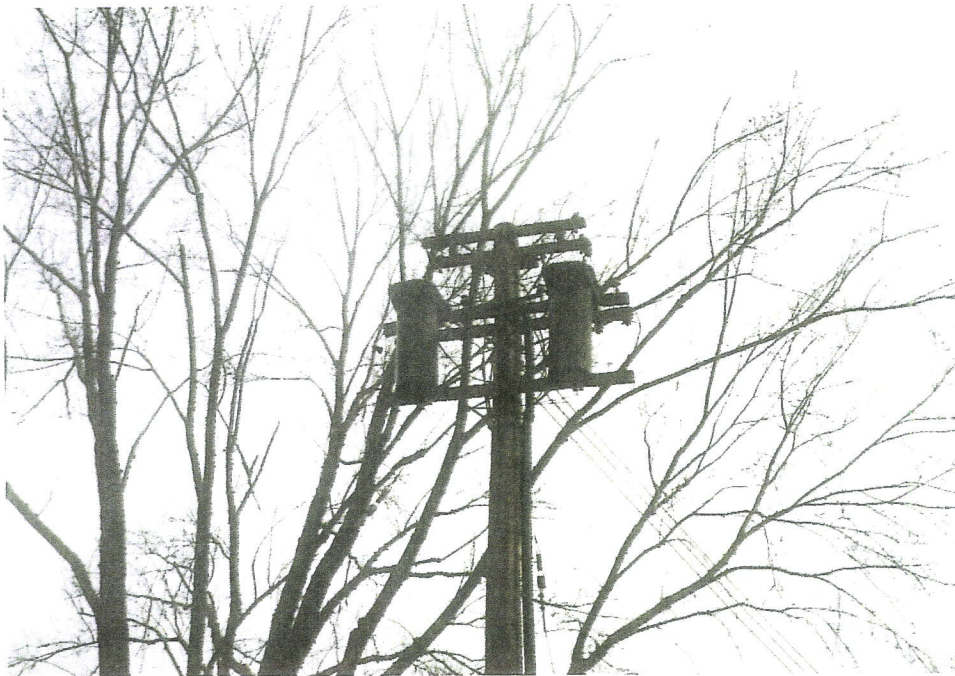
Photo 11: Two
Of Four
Westinghouse
Transformers
Located On Site.

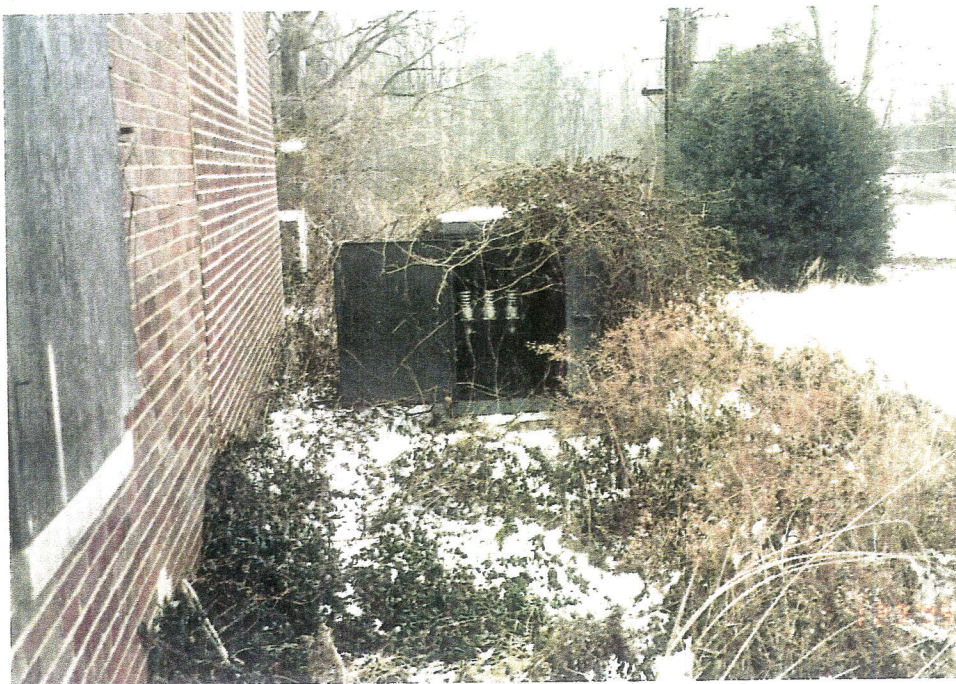
Photo 12: Pad-
Mounted
Transformer Near
Laundry Building.

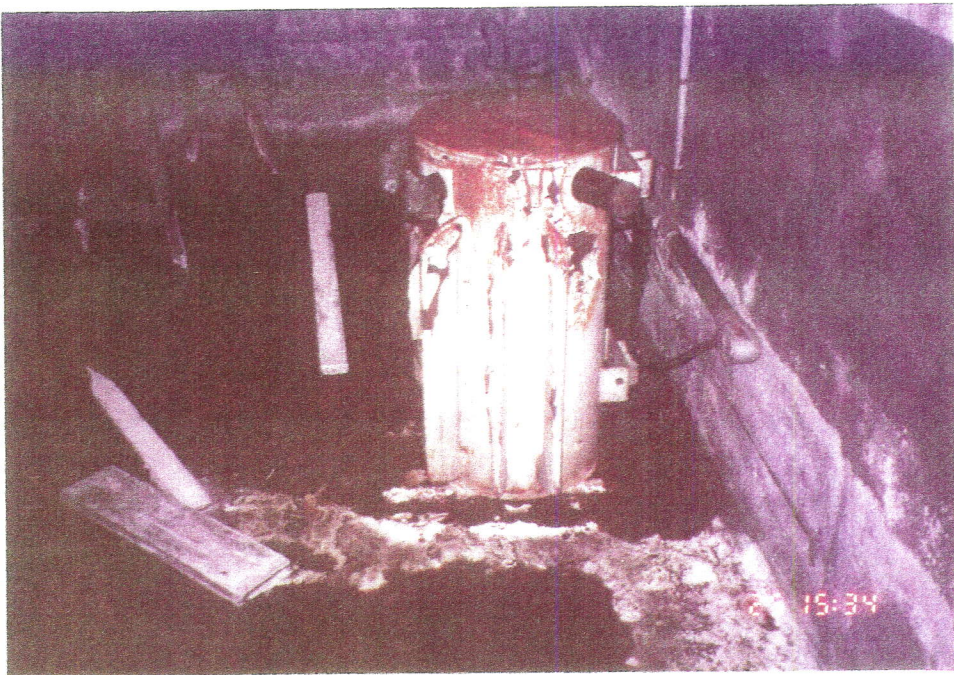
Photo 13:
Transformer
Located In The
Basement Electric
Room Area Of The
Children's Hospital
Building.

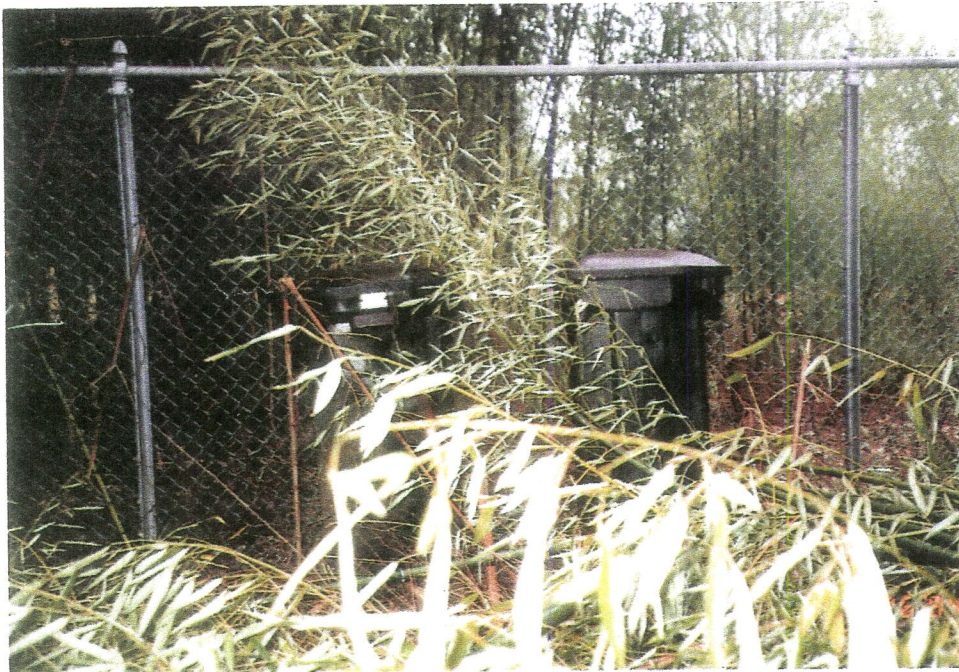
Photo 14: Two Of
Four Westinghouse
Transformers
Located On Site.

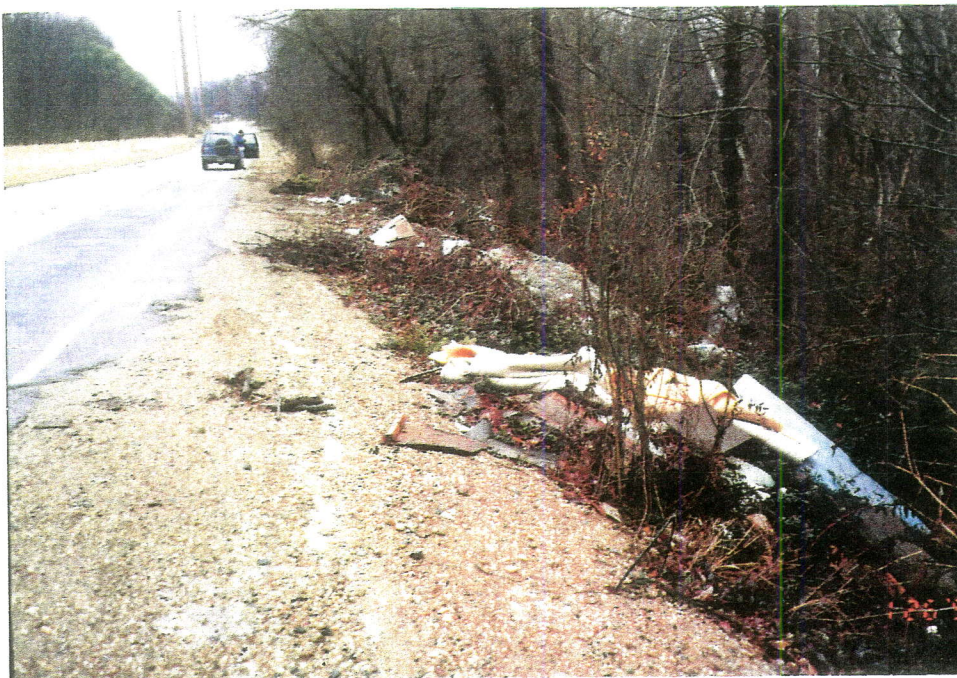
No evidence of buried drums, debris, rubble, or fill dirt was observed during the on site visit. However, PMT discovered areas throughout the site in which individuals have dumped household refuse, appliances, and used tires (Photos 15, 16, and 17). These areas should be cleaned. After the cleanup of these areas, security measures should be implemented on-site in order to discourage further dumping activities.

Photo 15: Trash
And Debris Located
On The North Side
Of Electric Road.

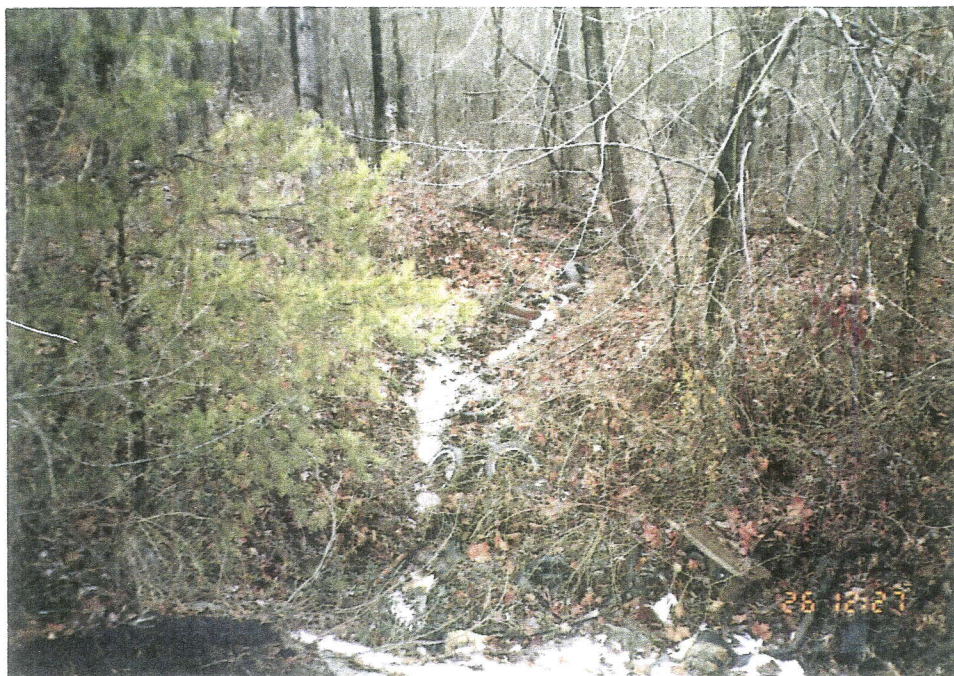
Photo 16: Tires
And Debris In
Woods North Of
Electric Road.

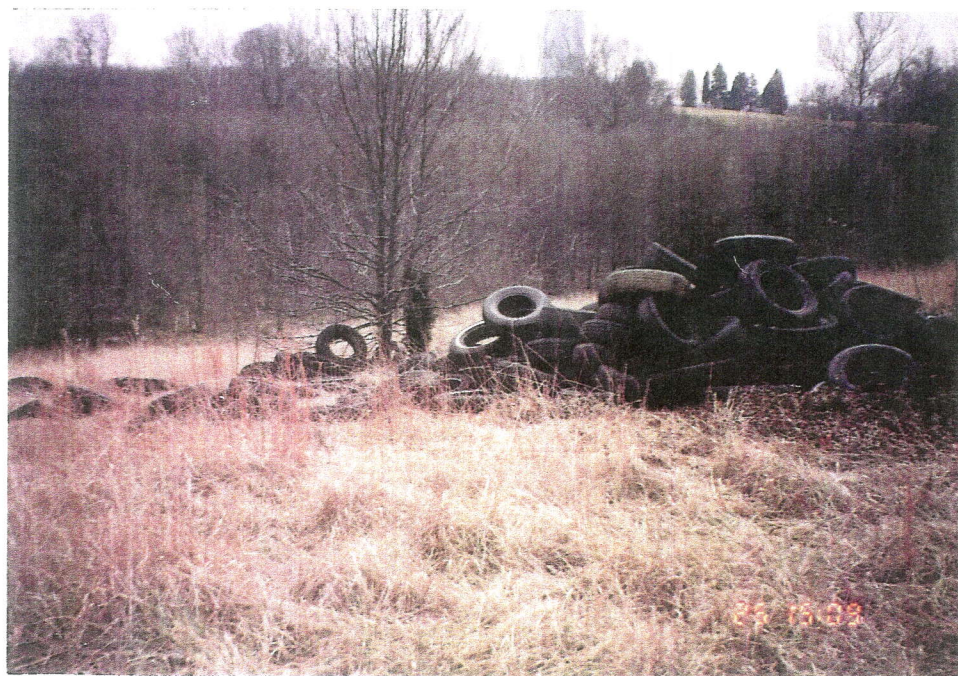
Photo 17: Tire
Dump South Of
Children's Hospital
Building.
