Asbestos-Containing Materials Report

**Former Glenn Dale Hospital Complex
5201 Glenn Dale Road
Glenn Dale, Maryland 20796**

April 5, 2013

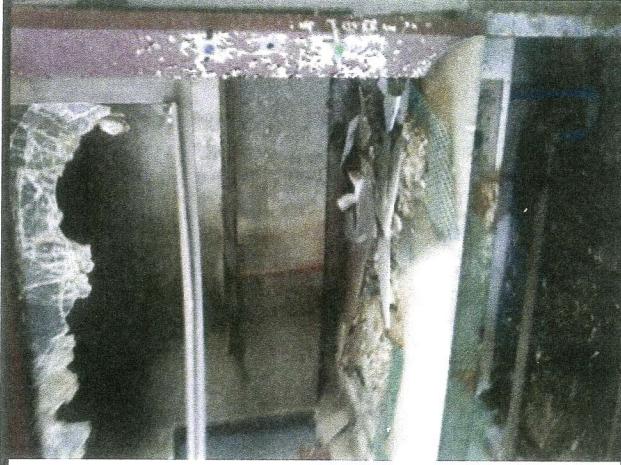
Asbestos-Containing Transite Hoods in 5th Floor Labs of Building 9

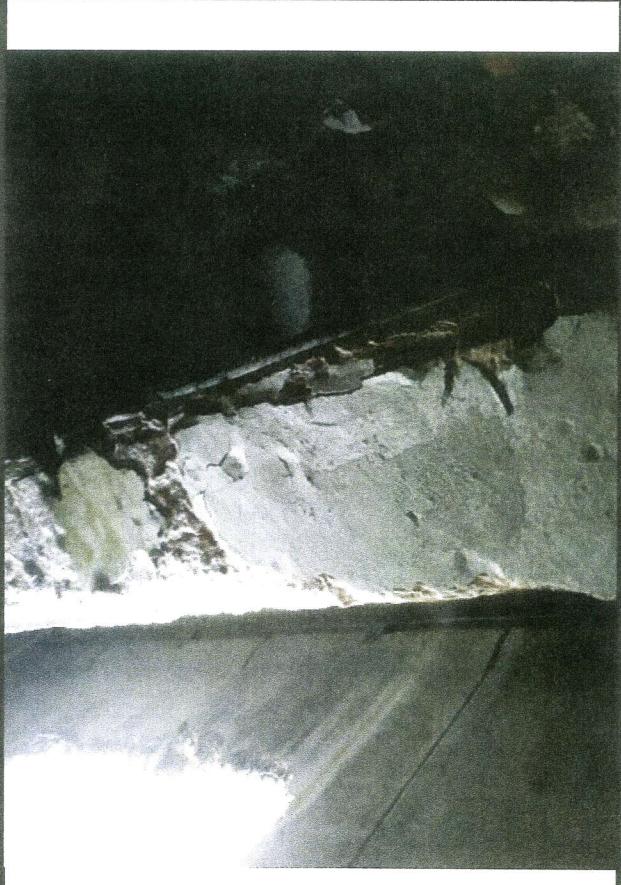
Asbestos-Containing Duct Insulation Coating in Attic of Building 9

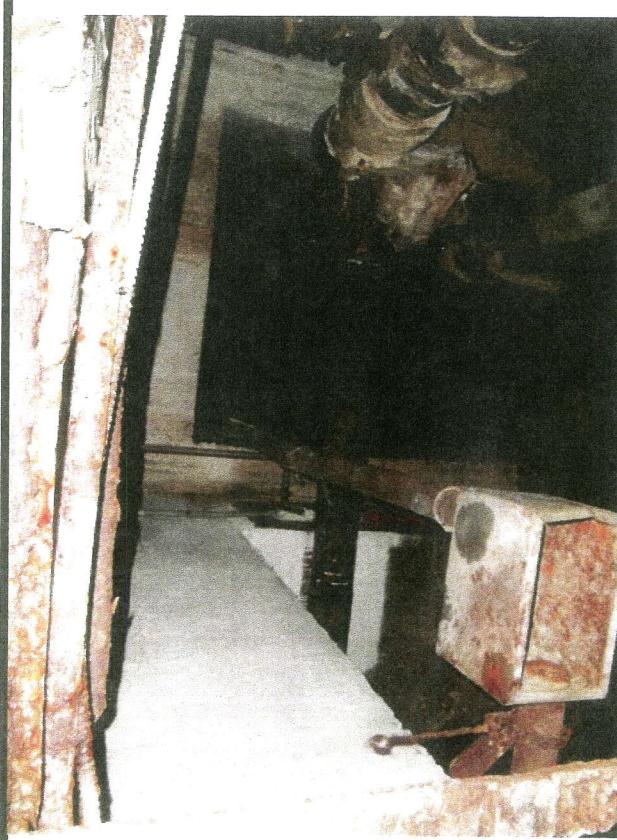
Steam Tunnels with 2 Steam Pipes Heading Southwest and Northwest from South End of Building 4

KCI identified buried steam pipes that connect Buildings 5, 8, 10, 16, 17, 20, 21 and 22 to the central Heating Plant. KCI was not able to observe these pipes, but has assumed that some asbestos-containing material is associated with these pipes. Prior to abatement design, KCI recommends an additional investigation to excavate at a representative number of locations to determine if asbestos-containing materials are present on the buried steam pipes. KCI has also made conservative assumptions about the locations of buried steam pipes, indicated in the site sketch included as Appendix A. KCI recommends additional investigation to identify locations and quantities of buried steam pipes.

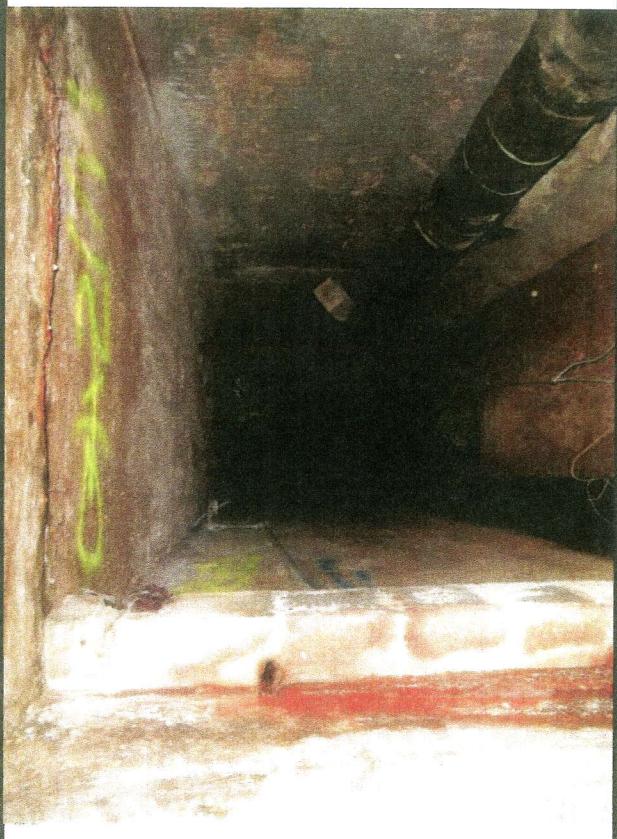
Steam Tunnel with 2 Steam Pipes Heading Northwest from Building 9

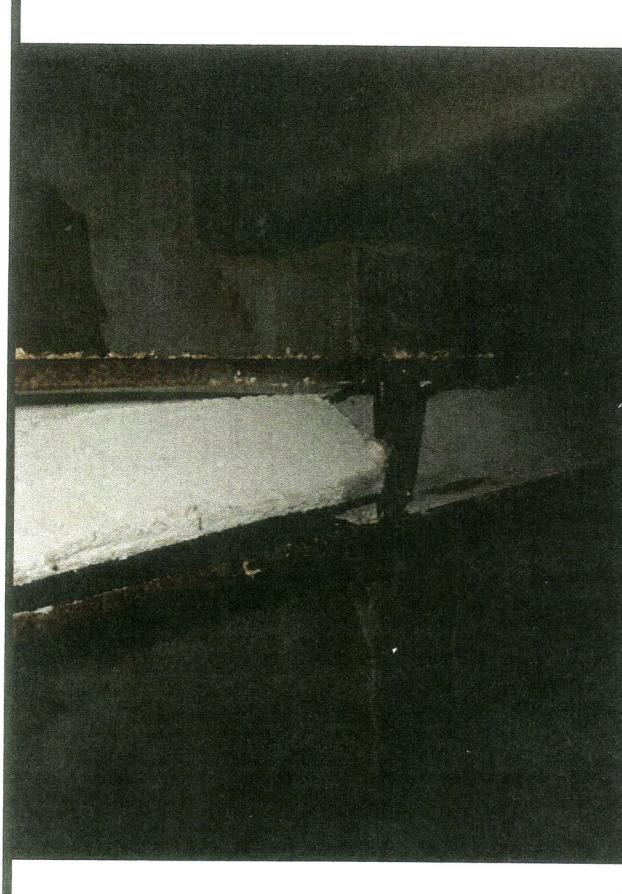
Asbestos-Containing Acoustical Surfacing in Soundproof Room in Basement of Building 9

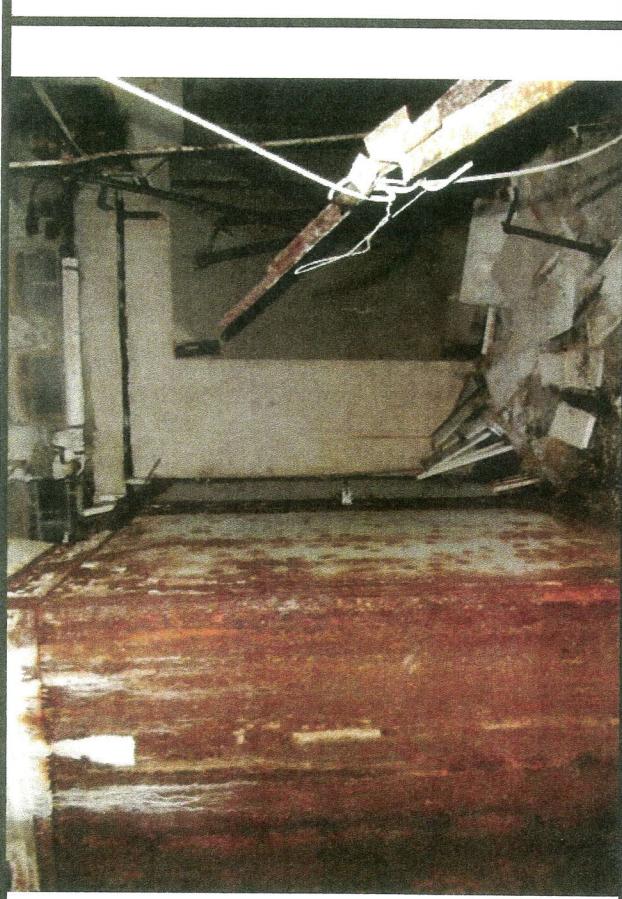
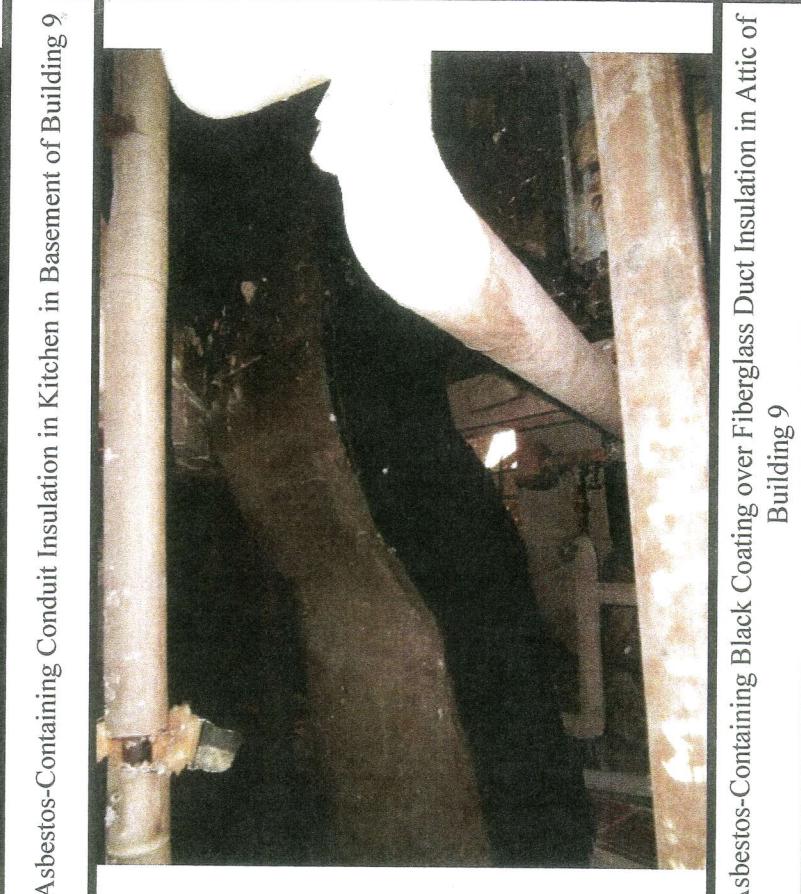
Asbestos-Containing Conduit Insulation in Kitchen in Basement of Building 9

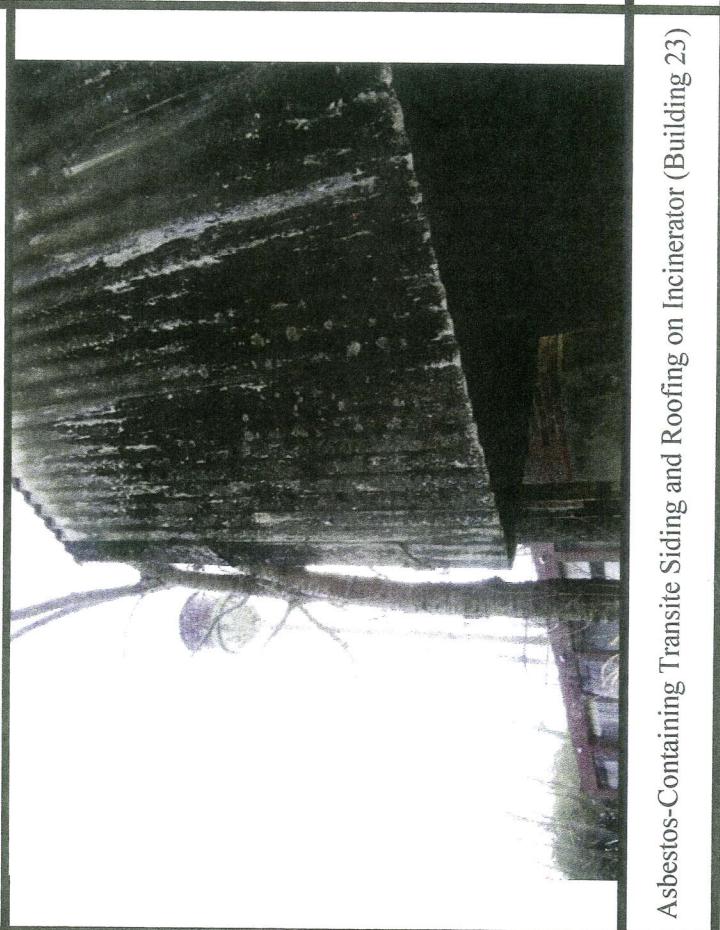
Asbestos-Containing Transite Siding and Roofing on Incinerator (Building 23) Building 9

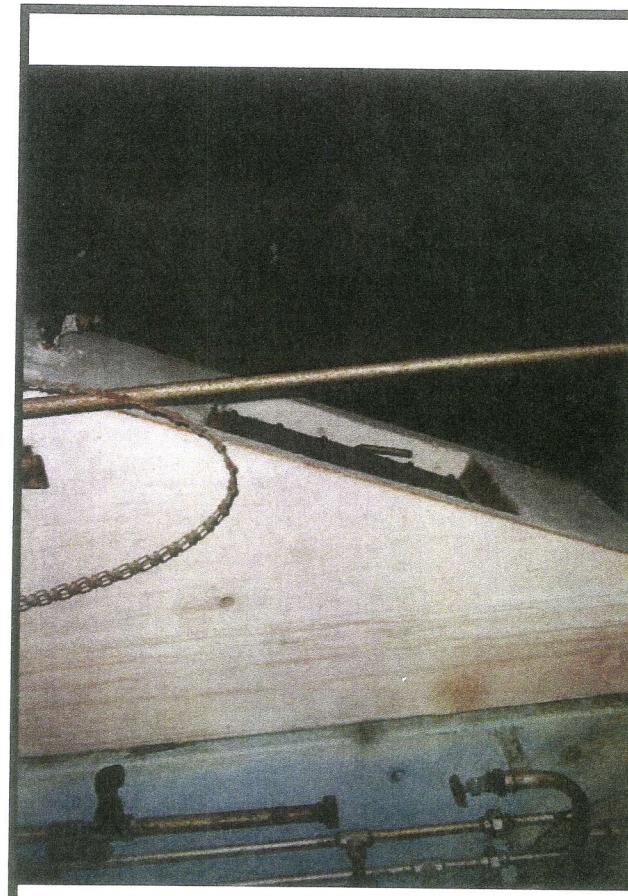
Asbestos-Containing Stack Insulation (Building 11)

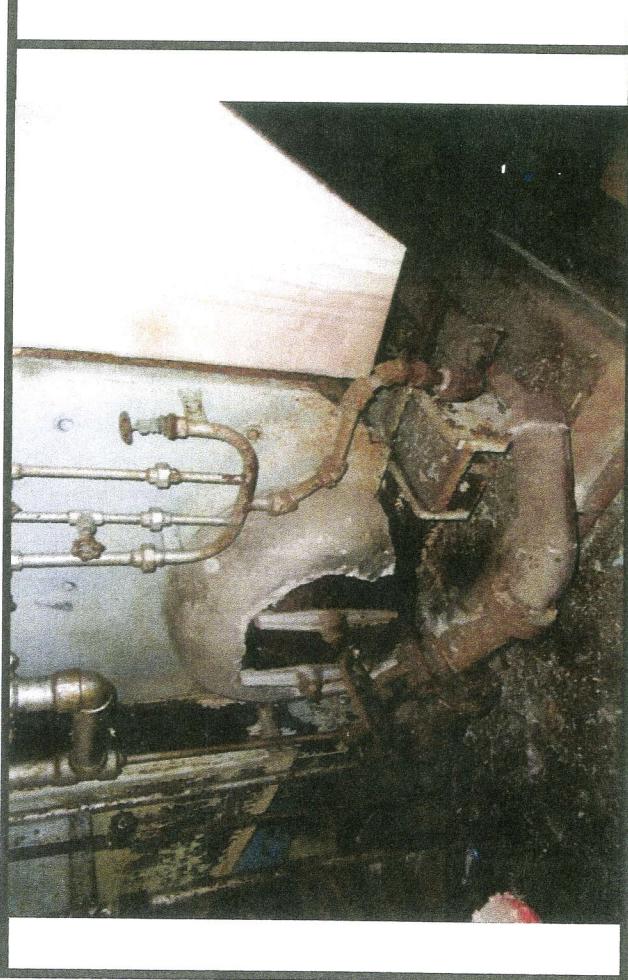
Asbestos-Containing Boiler Insulation (Building 11)

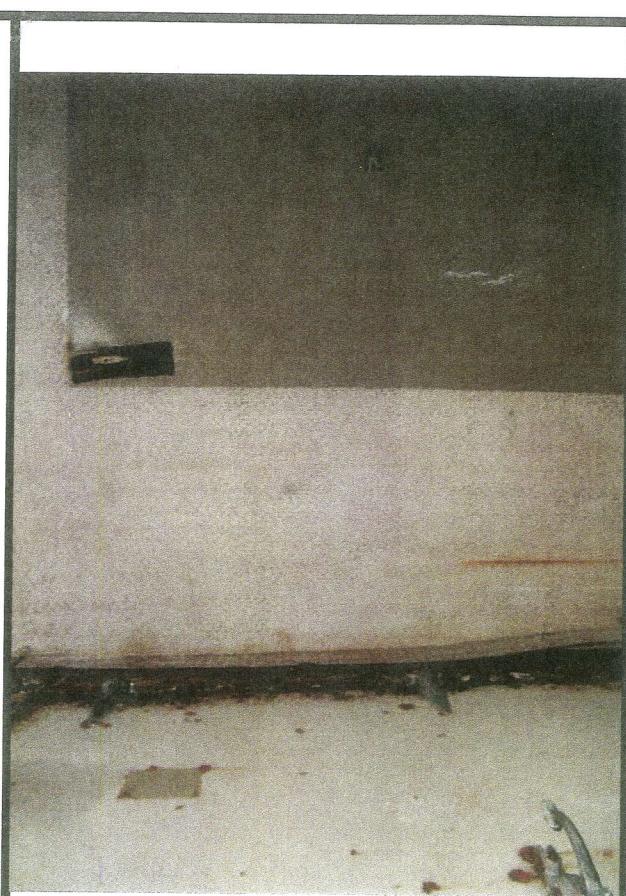
Asbestos-Containing Acoustical Surfacing in Soundproof Room in Basement of Building 9

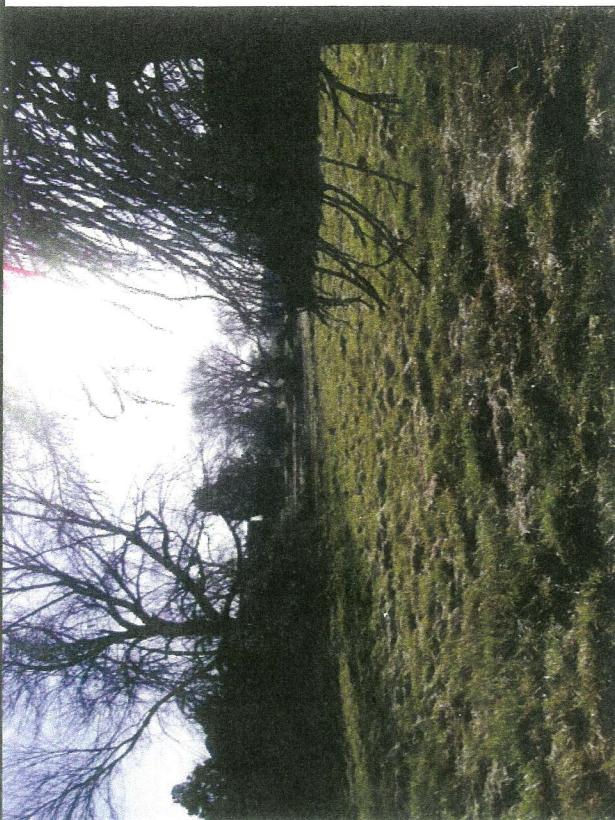
Building 6 could not be found and is presumed to have been demolished.

Building 7 could not be found and is presumed to have been demolished.

Area where Buildings 6 and 7 Stood

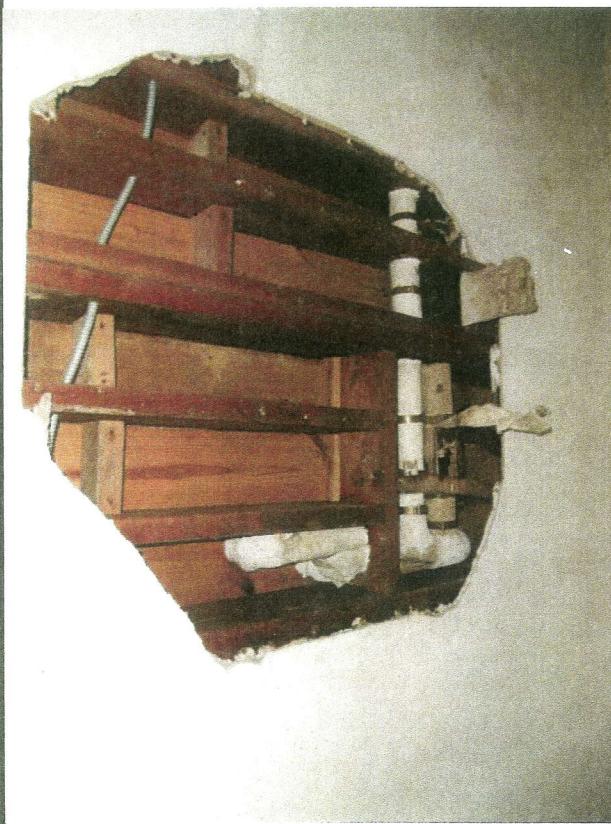
Building 8 contains asbestos-containing pipe insulation within plaster walls and above plaster ceilings. At the time of the survey, some of these walls and ceilings had collapsed or been demolished. KCI recommends an additional investigation prior to abatement design to update the location and quantity of walls and ceilings that will require demolition, as well as the quantity of plaster and other debris that has become contaminated with asbestos-containing pipe insulation. The quantities in the following table are based on current conditions, which are expected to continue to deteriorate with time.

Asbestos-Containing Pipe and Fitting Insulation above Plaster Ceiling
(Building 8)

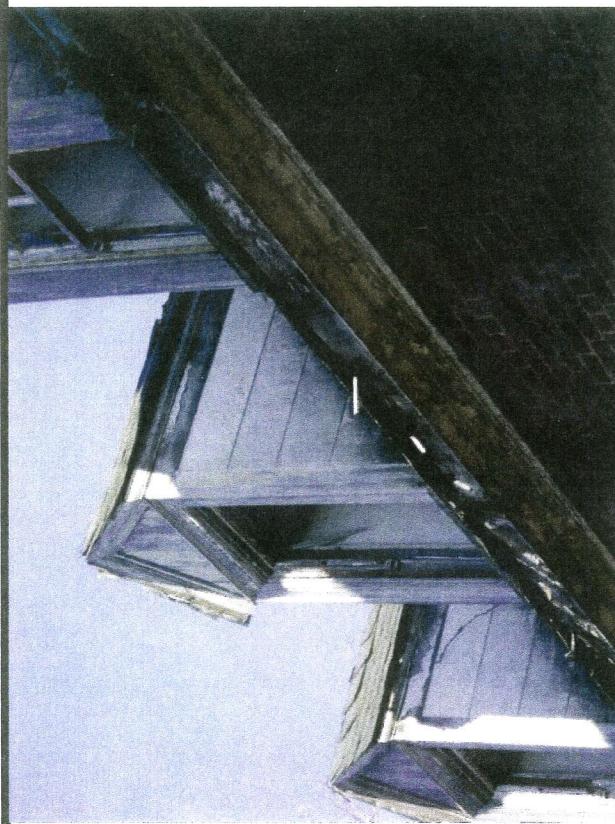
Transite Siding on Dormers (Building 1)

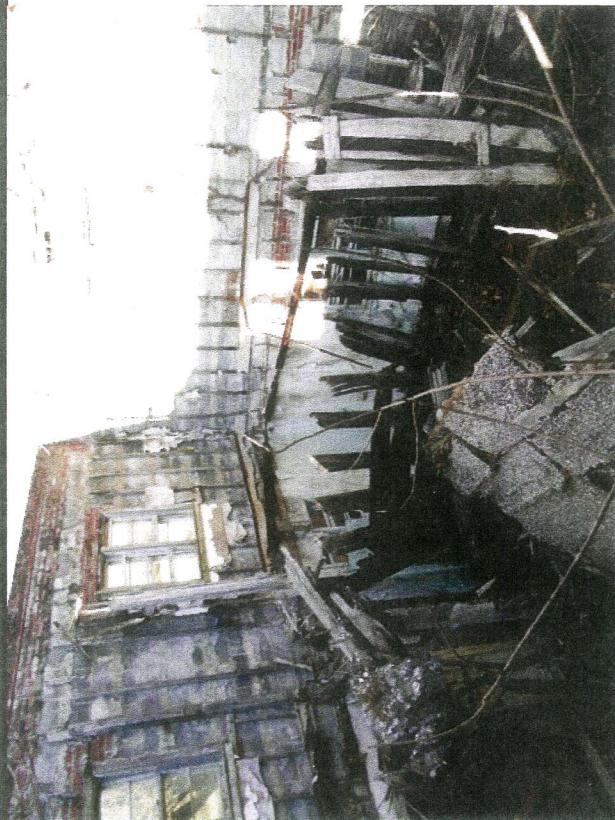
Building 20 has collapsed. KCI has assumed that Building 20 contained the same asbestos-containing materials that were found in Building 21, which is identical. KCI recommends that all of the debris from Building 20 be removed as asbestos-containing materials.

Debris Pile with Asbestos Contamination (Building 20)

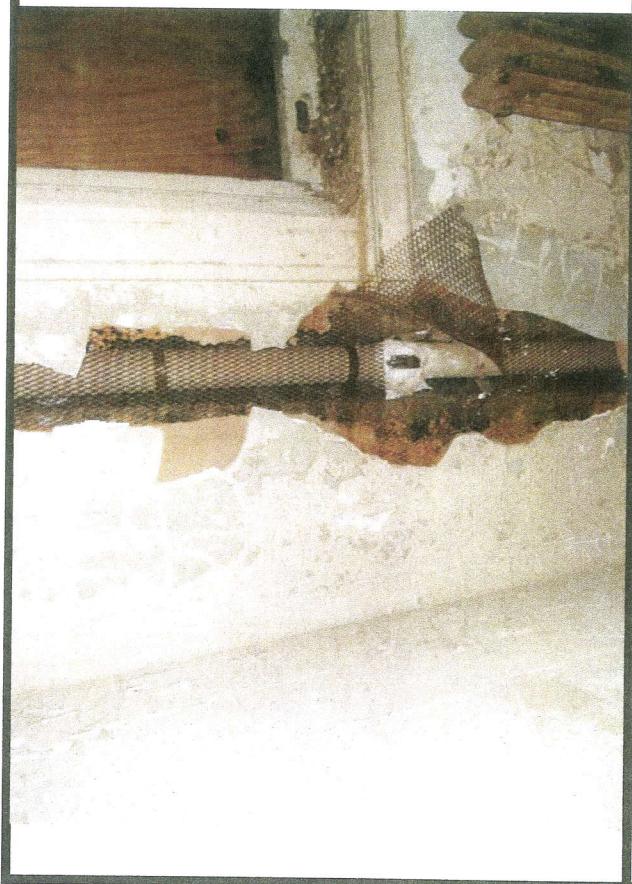
Building 1 contains asbestos-containing pipe insulation within plaster walls and above plaster ceilings. At the time of the survey, some of these walls and ceilings had collapsed or been demolished. KCI recommends an additional investigation prior to abatement design to update the location and quantity of walls and ceilings that will require demolition as well as the quantity of plaster and other debris that has become contaminated with asbestos-containing pipe insulation. The quantities in the following table are based on current conditions, which are expected to continue to deteriorate with time.

Asbestos-Containing Pipe Insulation within Plaster Wall (Building 1)

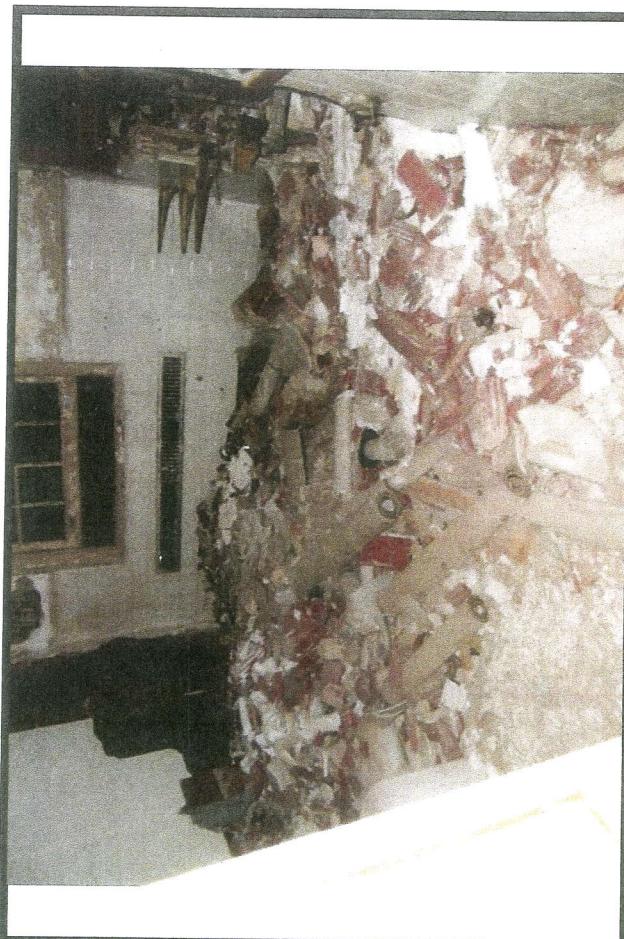
Building 2 contains asbestos-containing pipe insulation within plaster walls and above plaster ceilings. At the time of the survey, some of these walls and ceilings had collapsed or been demolished. KCI recommends an additional investigation prior to abatement design to update the location and quantity of walls and ceilings that will require demolition, as well as the quantity of plaster and other debris that has become contaminated with asbestos-containing pipe insulation. The quantities in the following table are based on current conditions, which are expected to continue to deteriorate with time.

Asbestos-Containing Pipe Insulation with Plaster and Terra Cotta Wall Debris (Building 2)

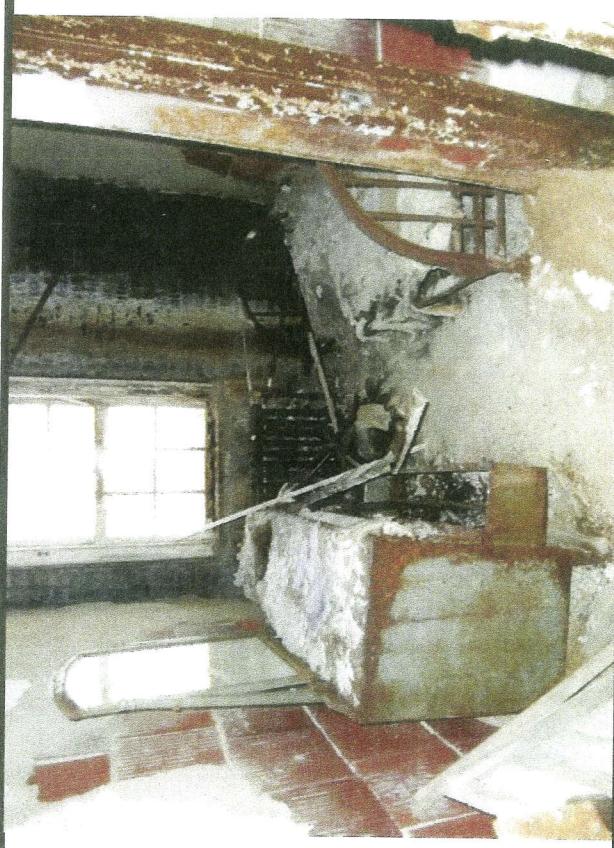
Plaster Debris with some Asbestos-Containing Pipe Insulation Contamination (Building 18)

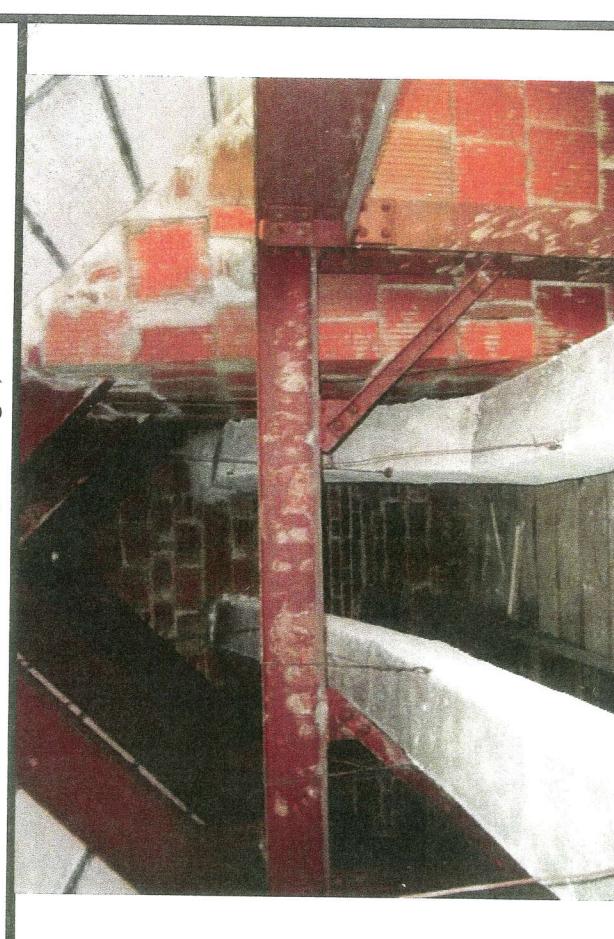
Building 4 contains asbestos-containing pipe insulation within plaster walls and above plaster ceilings. At the time of the survey, some of these walls and ceilings had collapsed or been demolished. KCI recommends an additional investigation prior to abatement design to update the location and quantity of walls and ceilings that will require demolition, as well as the quantity of plaster and other debris that has become contaminated with asbestos-containing pipe insulation. The quantities in the following table are based on current conditions, which are expected to continue to deteriorate with time.

Asbestos-Containing Duct Insulation in Attic of Building 4

Portions of Building 4 may be structurally unsound. KCI recommends that the structure be assessed prior to abatement to determine if abatement can be performed safely.
