**PHASE I ENVIRONMENTAL ASSESSMENT
GLENN DALE HOSPITAL
5201 GLENN DALE ROAD
GLENN DALE, MARYLAND 20769**

**THE MARYLAND-NATIONAL CAPITAL
PARK AND PLANNING COMMISSION
6600 KENILWORTH AVENUE
RIVERDALE, MARYLAND 20737**

**PMT & ASSOCIATES, INC.
73 WEST TIMONIUM ROAD
TIMONIUM, MARYLAND 21093**

**FEBRUARY 10, 1994
PMT PROJECT: 94-23-02**

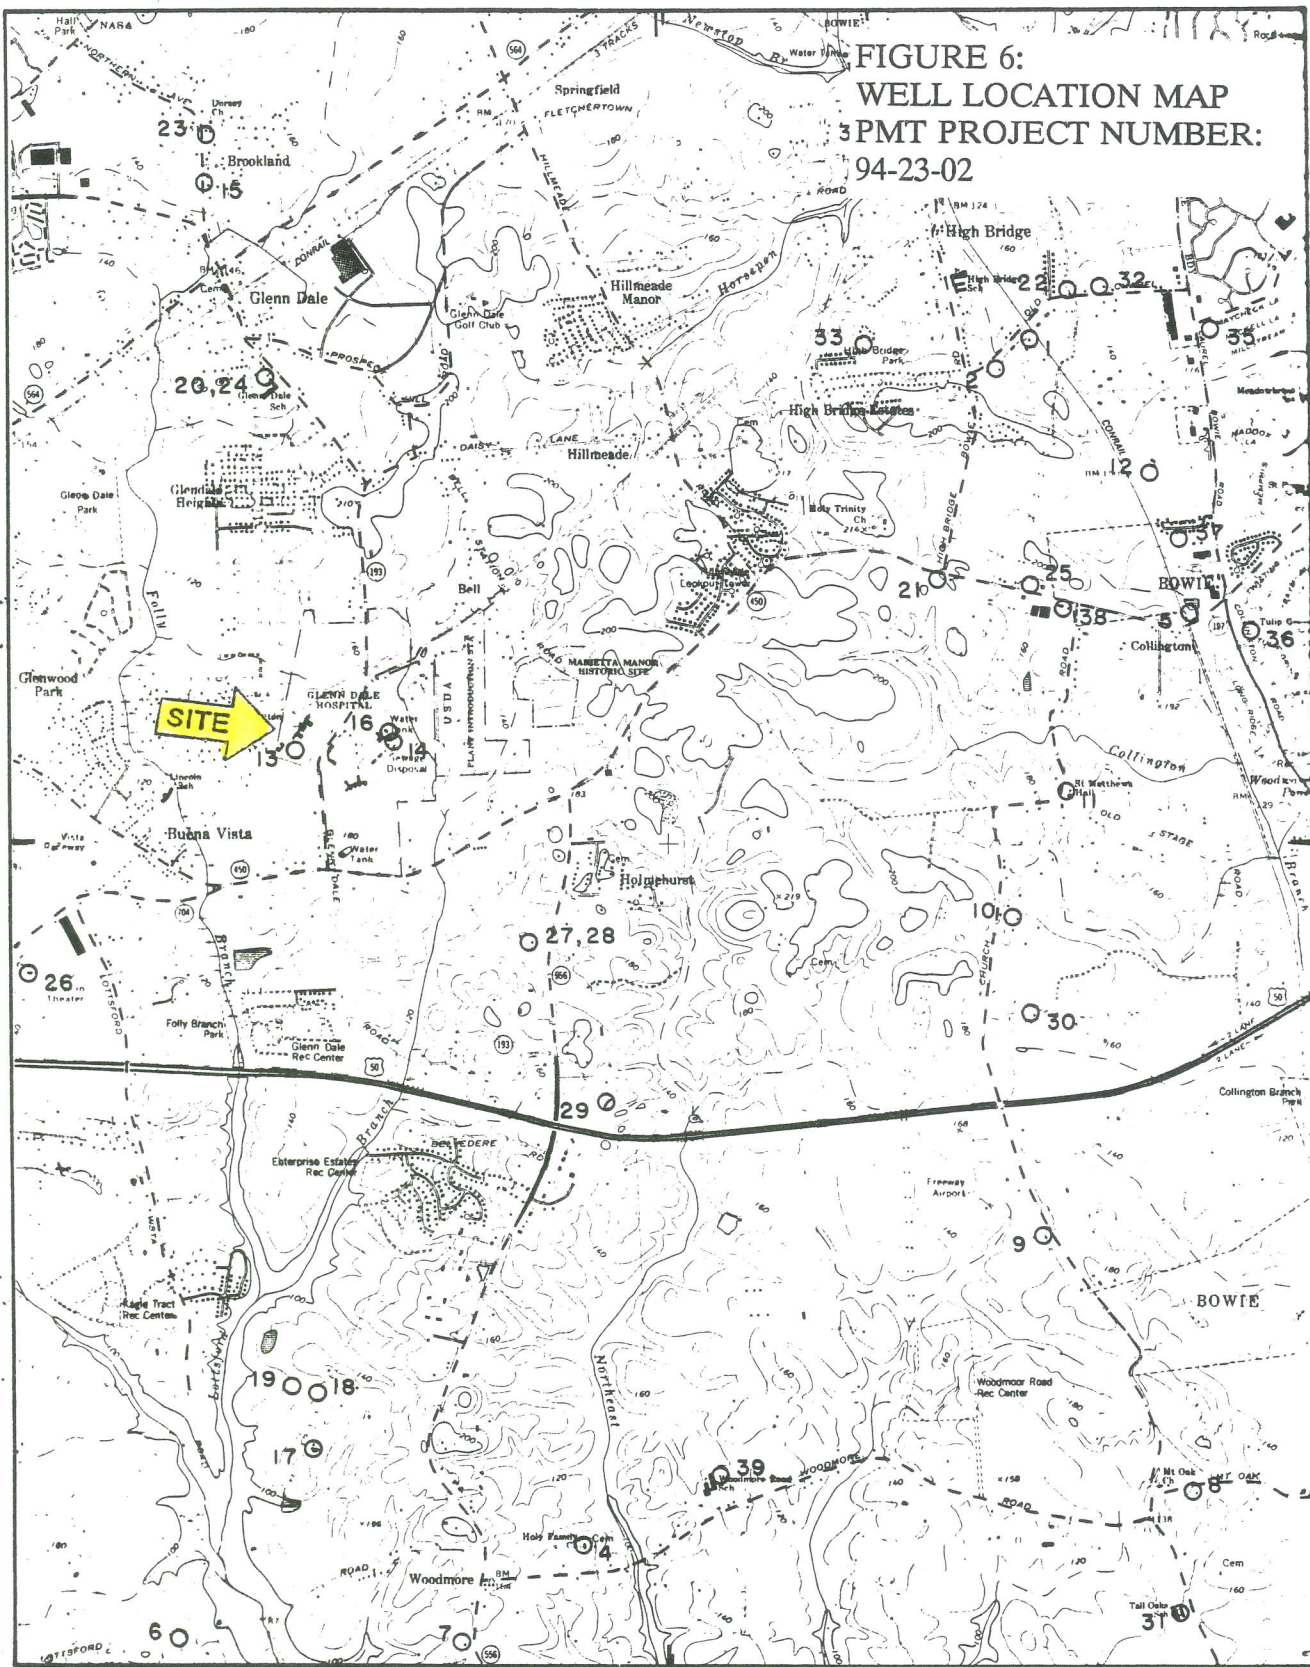
FIGURE 6:
WELL LOCATION MAP
PMT PROJECT NUMBER:
94-23-02

Review of the Department of Natural Resources, "Water Resources Basic Data Report No. 13, the Prince George's County Ground-Water Information indicated that there are three (3) wells drilled on site. These wells are designated as Ce 13, Ce 14, and Ce 16. Well Ce 13 is located to the southwest of Finucane Hall and is drilled to a depth of 798 feet below ground surface into the Patapsco formation aquifer. Well Ce 14 is located on the eastern side of the property near the sewage treatment building. The well is drilled to a depth of 316 feet below ground surface in the Patapsco formation aquifer. Well Ce 16 is located near the water tower. The well is drilled to a depth of 946 feet below ground surface into the Patapsco and the Patuxent formations aquifers.

These wells, as they exist now, are a possible pathway for future ground water contamination (Figure 6). They should be located and properly abandoned.
