GLENN DALE HOSPITAL HISTORIC DISTRICT

Field Observations Report

prepared for
M-NCPPC
Prince George's County
Department of Parks
& Recreation

June 8, 2015

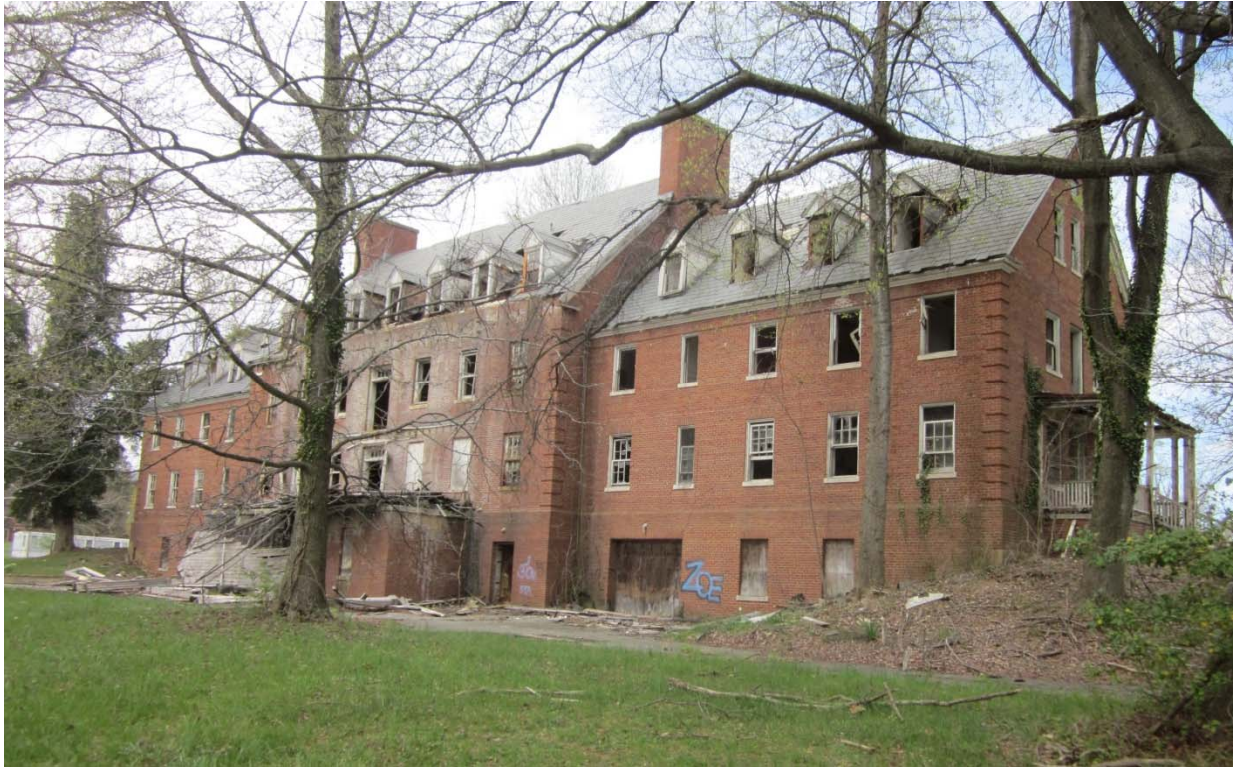
Figure 2.2- 5 McCarren Hall (Building 8b) –1935 (rear)

McCarren Hall (Building 8b) features a different plan, and consists of a two-and-a-half story tall main block constructed from brick-clad reinforced concrete, with two-story flanking wings of similar construction. A large two-story porch on the rear of the building has fallen. The building features 6-over-6 wood double-hung windows, and wood-sided dormers on the gabled slate roof supported by steel framing. The Colonial Revival-style building has a brick water table, brick quoining, a wood pediment and trim at primary entrances, and limestone window sills (Figure 2.2-5).

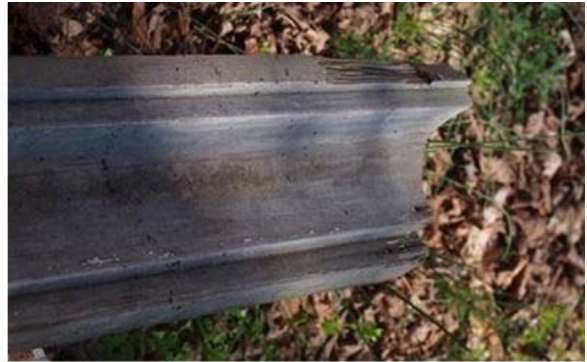
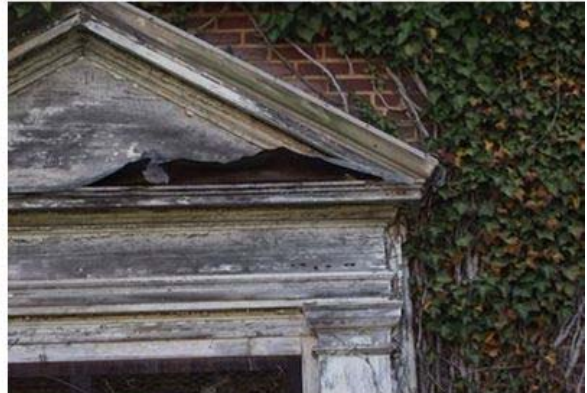
Figure 4.1- 4 Various woodwork conditions found at the Glenn Dale Hospital Historic District.

Despite being at the mercy of the elements, many of the wooden components appear to be in fair condition. In some cases, small elements may be missing such as plinth blocks. However, in rarer cases, entire assemblages are missing, such as the frontispiece on Capper Hall, and nearly all of the wooden exterior cornices.

- All exterior elements have flaking paint, significantly shortening the lifespan of unprotected wooden elements.
- Some elements are in poor condition, but could be repairable.
- Some components missing.
- Many of the wooden cornices on the buildings are beyond repair.

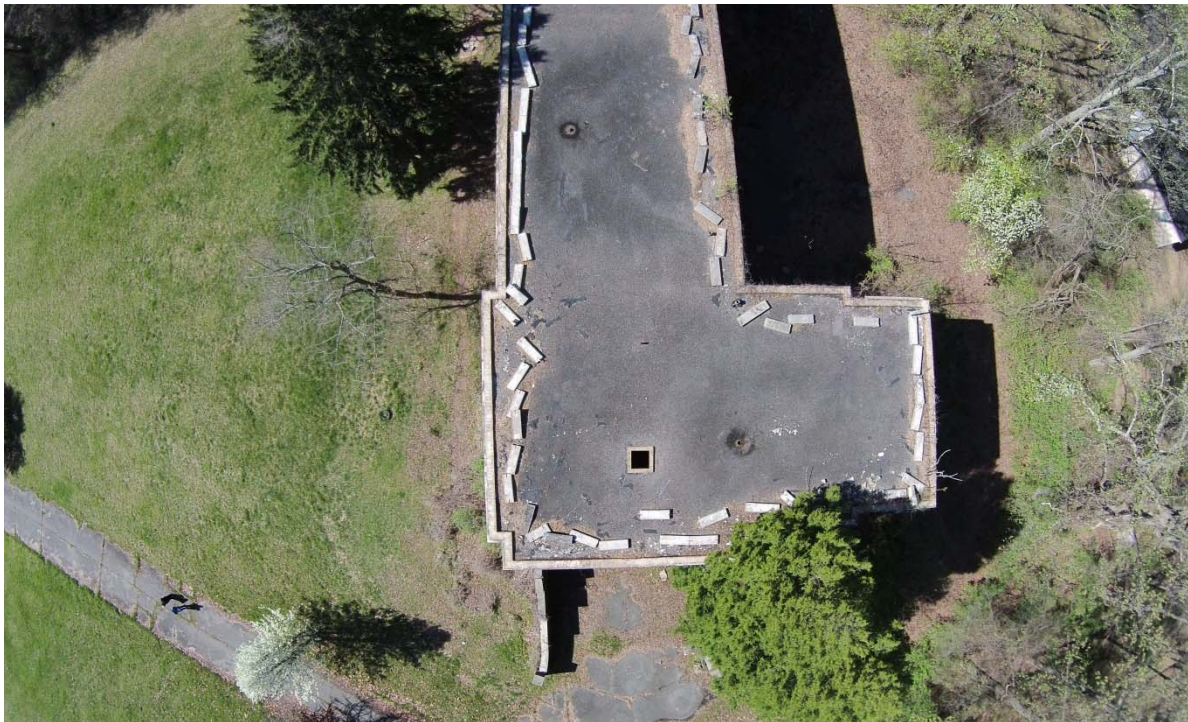
Figure 4.1- 10 Aerial view of Finucane Hall. Note the removed stone parapet caps that have been placed on the roof.

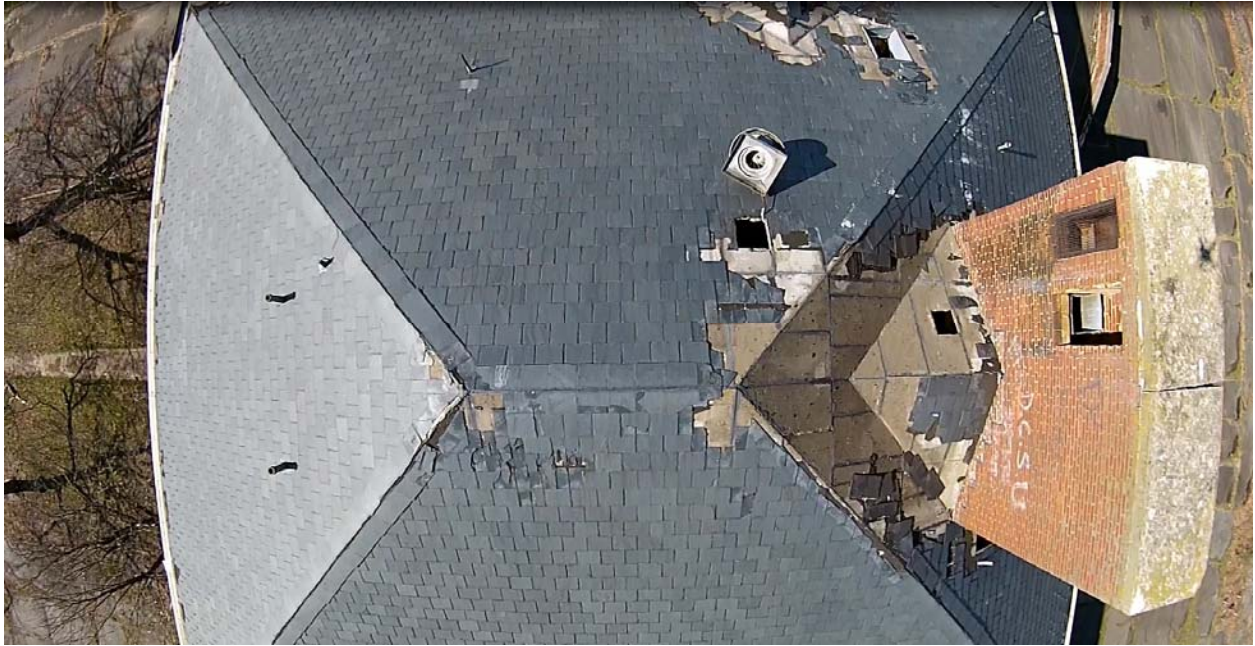
Figure 4.1- 11 Adult Hospital pyramidal roof. Note the slates and flashing removed from the cricket.

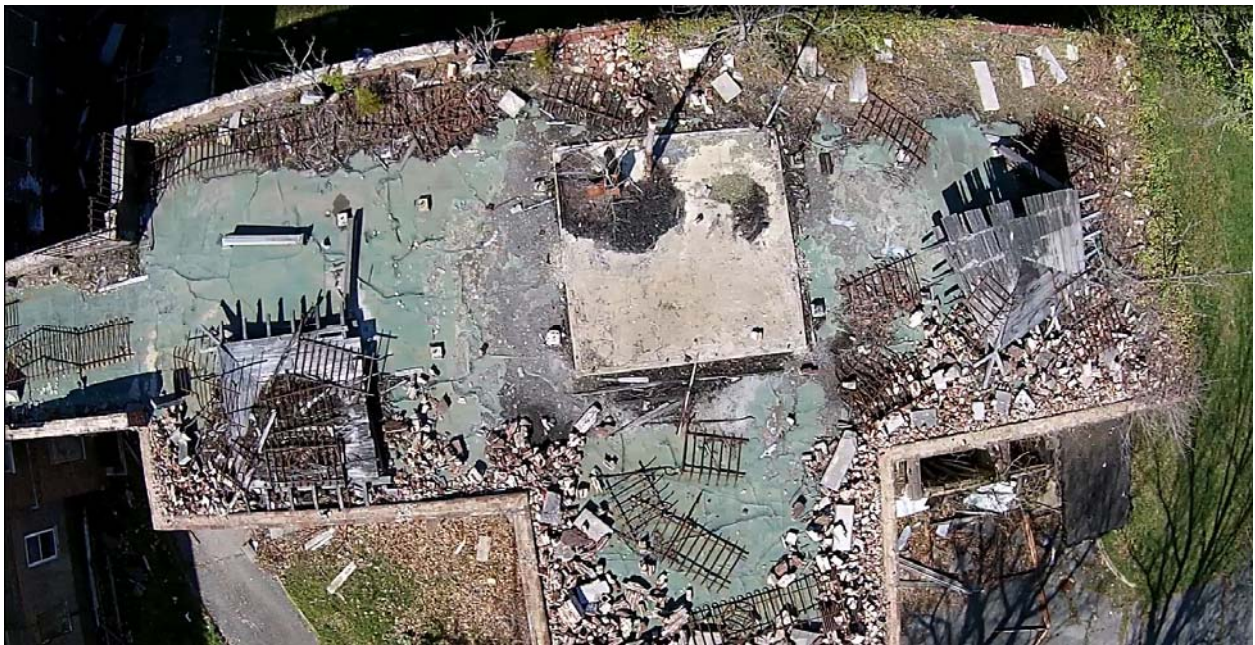
Figure 4.1- 12 Peabody Hall flat roof. Note the debris from the pergola, parapets, and iron railings.

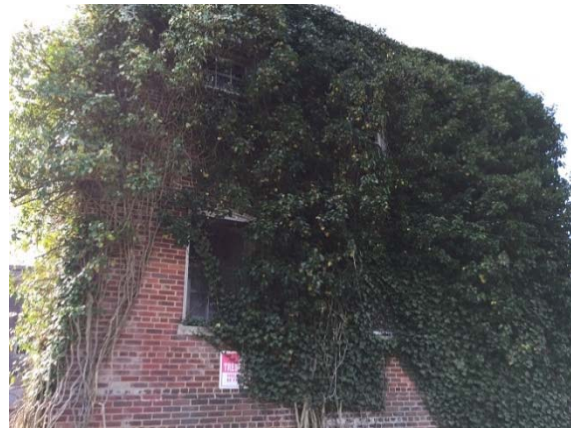
Figure 4.2- 3: Vegetation along Façade (SW Corner)

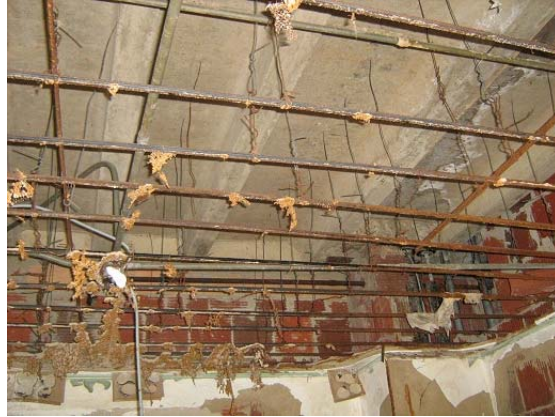
Figure 4.2- 9: Typical Concrete Floor Slab and Ceiling Hangers

The structure for the Children's Hospital appears to consist of a pan-joint concrete slab framing to concrete beams, which in turn frame to concrete columns. It is possible that the concrete beams and columns are instead concrete-encased steel beams and columns, but we were not able to confirm this. The condition of the structure is good.

Isolated areas of corrosion of the reinforcing are evident at random locations but the extent of this damage does not appear to be widespread. Corrosion of the interior steel stairs is also evident. Treads have been lost in several of the runs.

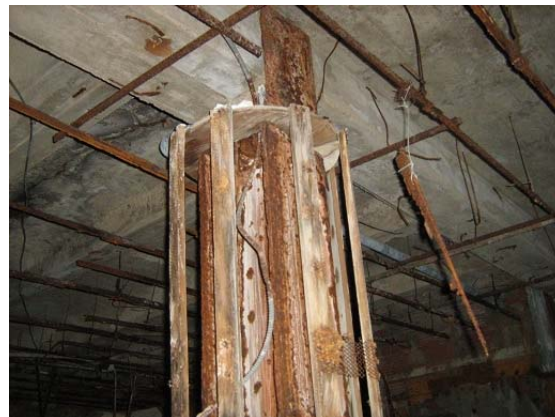
Figure 4.2- 11: Basement Steel Column

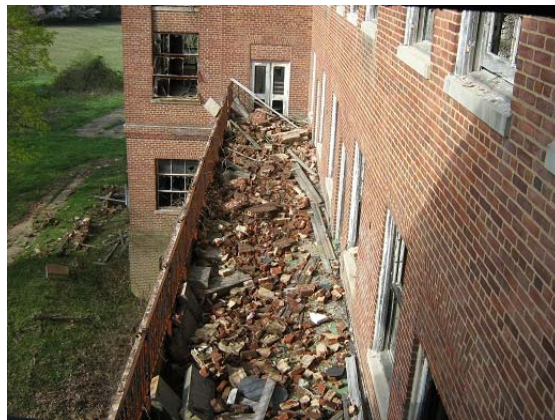
In many areas of the building, the parapet has fallen on one of the lower level balconies. We did not observe any significant structural damage of the soffit or the balcony slabs due to the impact of the fallen masonry. The loss of the parapet does not represent a loss of structural integrity of the building, but the loose brick and other materials should be removed to prevent damage from fallen debris.

Figure 4.2- 15: Parapet Debris at 2nd Floor Balcony

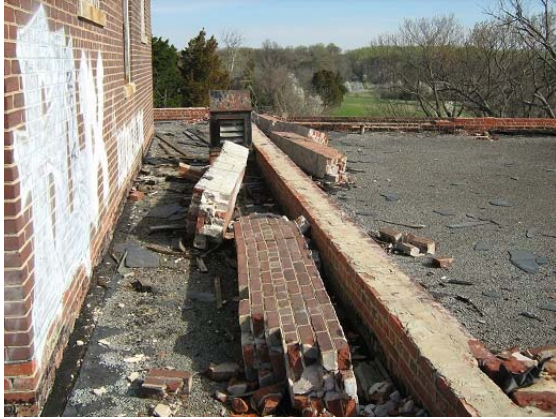
The single most distinctive structural damage to the Children's Hospital is the failure/destruction of the roof parapet. Most of the roof parapet has failed or has been removed by thieves above the fourth course of brick. The failure plane is consistent along the entire perimeter, which could be an indication that the parapet was "demolished" by thieves to remove the copper flashing evident in small areas of the remaining parapet.

Figure 4.2- 16: Typical Fallen Parapet

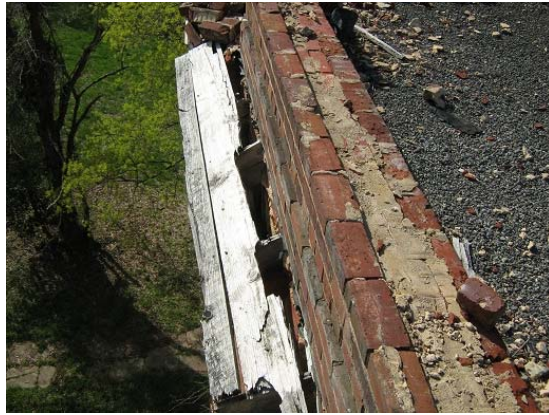
Figure 4.2- 17: Rotted Wood Cornice and Fallen Parapet

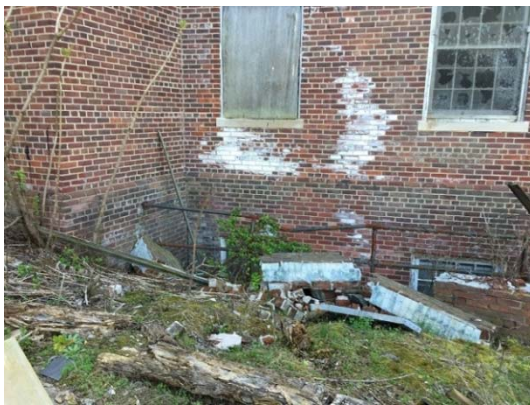
Figure 4.2- 18: Fallen Parapet

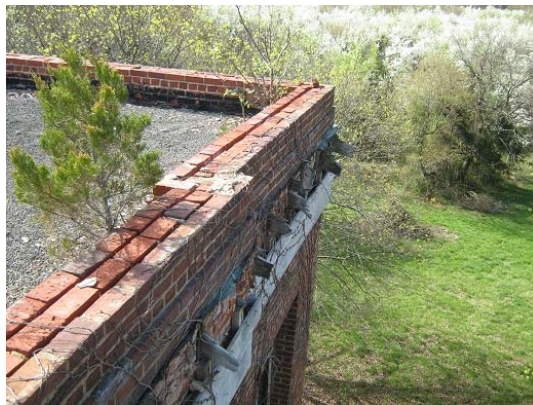
Figure 4.2- 19: Vegetation on Roof; Open Collar Joints in Parapet

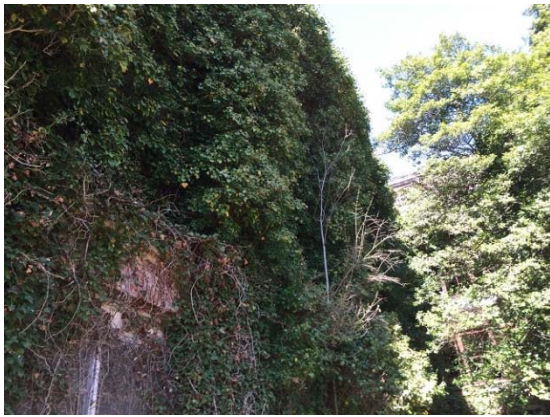
Figure 4.2- 24: Vegetation along Façade

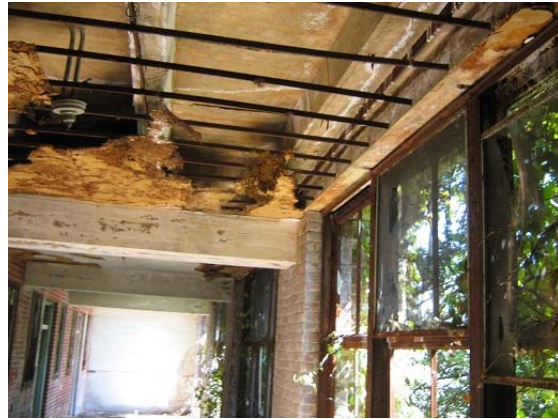
The structure for this building appears to consist of a pan-joist concrete slab framing to concrete beams, which in turn frame to concrete columns. It is possible that the concrete beams and columns are instead concrete-encased steel beams and columns, but we were not able to confirm this. The condition of the structure is good. Isolated areas of corrosion of the reinforcing bars in some beams and slabs are evident at random locations, but the extent of this damage does not appear to be widespread.

Figure 4.2- 27: Typical Concrete Slab and Ceiling

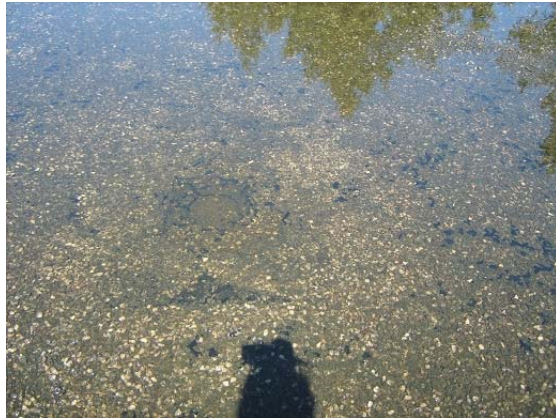
Figure 4.2- 36: Clogged Drain

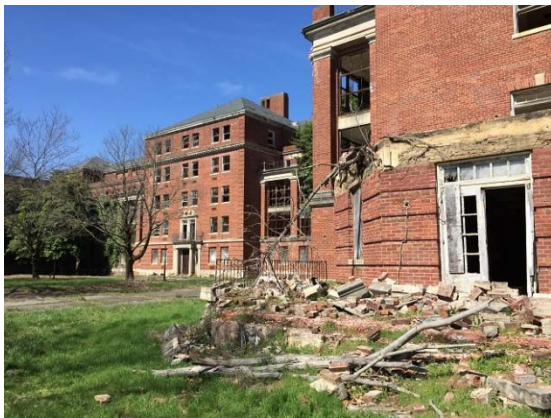
Figure 4.2- 37: North East Entrance Damage

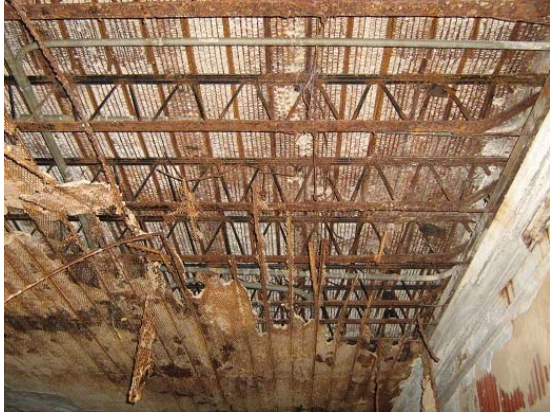
The structure for the floors of Capper Hall appears to consist of a metal deck spanning to steel joists. It also appears that these steel joists are supported by load-bearing masonry walls (could not determine if a steel frame provides support). The roof framing consists of wood decking and wood rafters. The condition of the floor framing is fair. Many of the visible areas show evidence of corrosion of the joists. The condition of the roof framing is poor. It has failed at many locations and is allowing water to enter the building.

Figure 4.2- 42: Typical Floor Framing - Corrosion in Joists

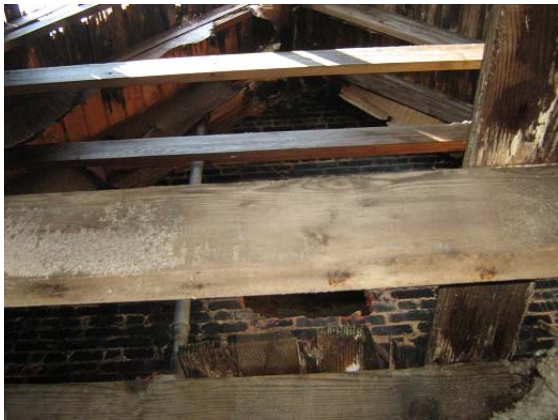
Figure 4.2- 44: Rotted Roof Decking

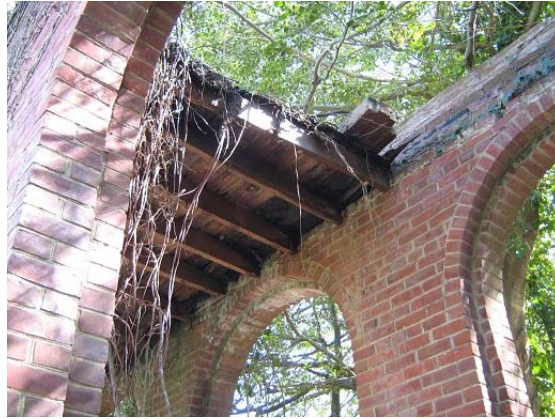
The connecting arcade framing consists of masonry walls and a wooden roof. A significant area of the wooden roof has failed due to water damage. If left unattended, further collapse of this roof will eliminate the top bracing of the arcade walls, which could lead to failure of these walls.

Figure 4.2- 47: Collapsed Arcade Roof

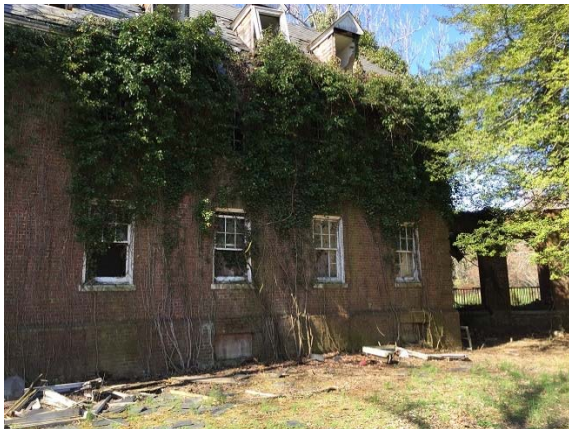
Figure 4.2- 50: Vegetation along Front Facade

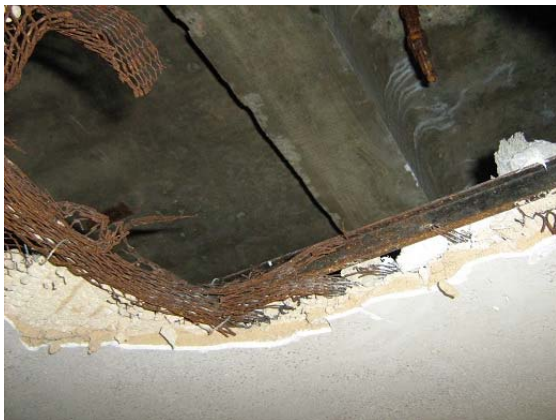
Figure 4.2- 54: Underside of Roof Decking

The roof framing for McCarren Hall consists of structural steel rafters that support steel purlins, which in turn support what appear to be lightweight concrete / clay roof panels and a slate roof. The roof has totally failed in many areas of the building.

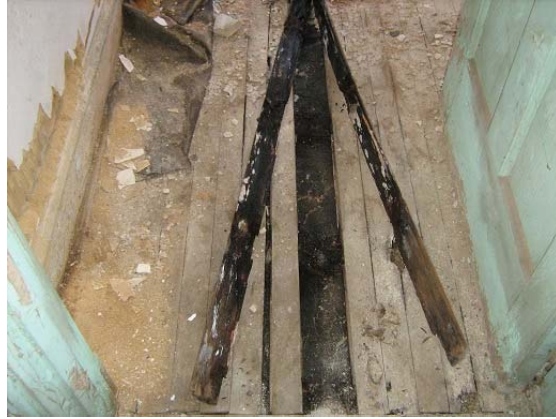
Figure 4.2- 57: Rotted Flooring

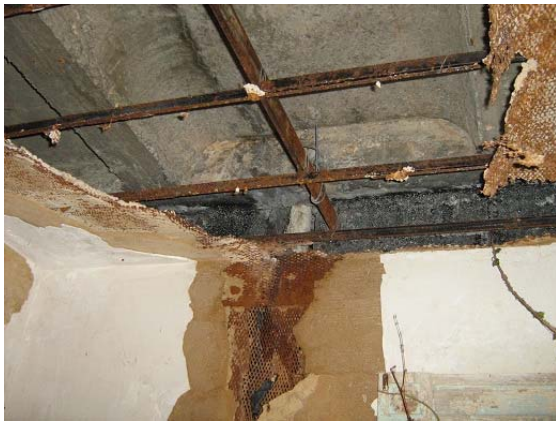
Figure 4.2- 58: Typical Concrete Framing and Ceiling Hangers

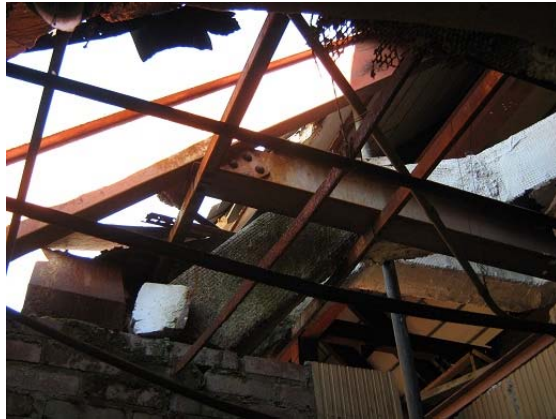
Figure 4.2- 60: Steel Roof Framing in Collapsed Area

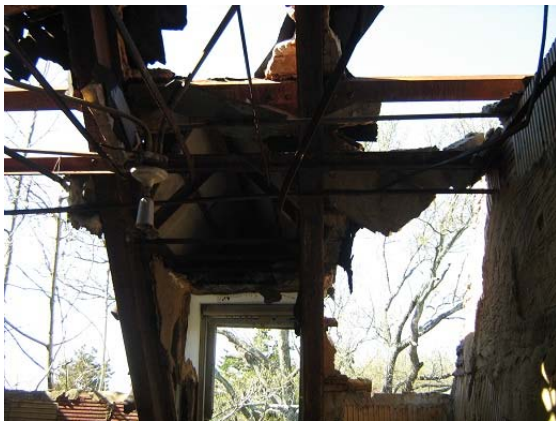
Figure 4.2- 61: Collapsed Roof in Dormer Area

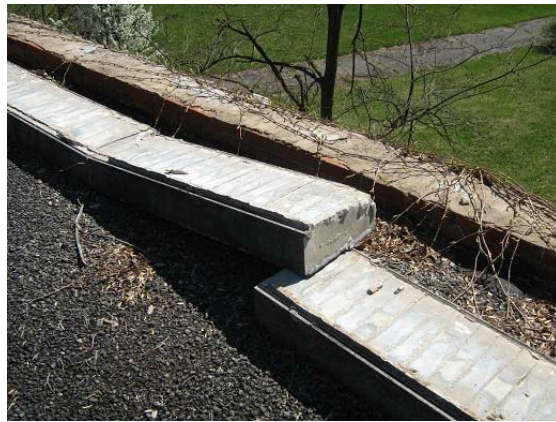
No significant structural damage was observed. Cracking of the masonry at some of the roof parapets is evident. The cast stone cap of the parapet has been removed along the entire perimeter. Significant areas of standing water are visible at the basement level and corrosion of the steel stairs is also evident. Treads have been lost in several of the runs.

Figure 4.2- 75: Removed Cap Stone

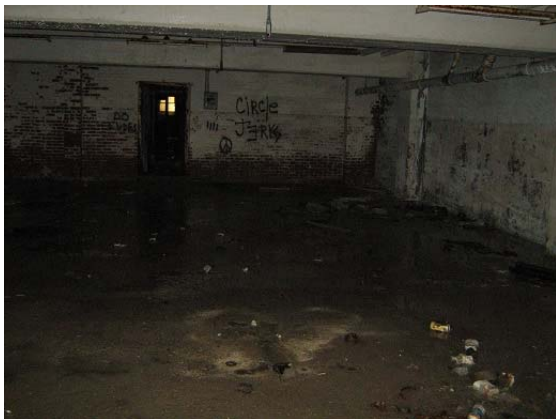
Figure 4.2- 76: Standing Water in Basement Slab

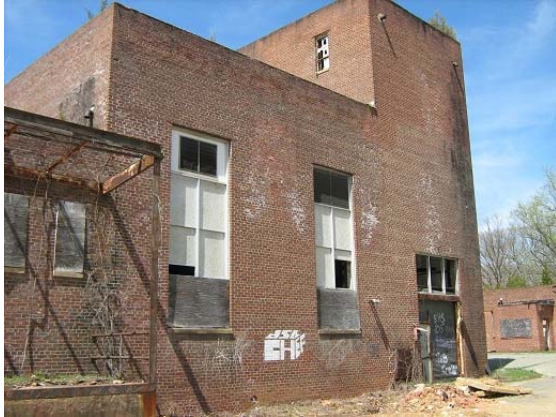
Figure 4.2- 78: SE Elevation - Heating Plant

We could not access the interior of this building, but it appears to consist of a pan-joint concrete slab framing to concrete beams, which in turn frame to concrete columns. It is possible that the concrete beams and columns are instead concrete-encased steel beams and columns, but we were not able to confirm this. The condition of the structure appears to be good. No significant structural damage was observed from the outside.

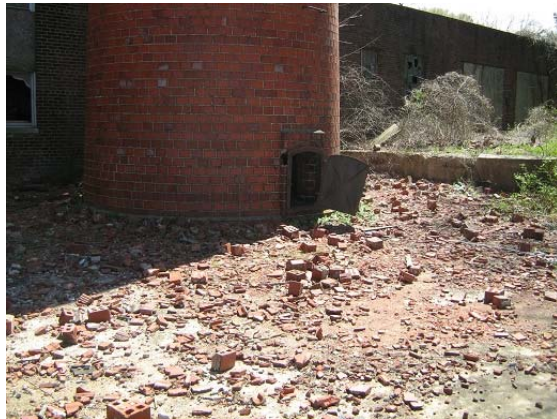
Figure 4.2- 81: Masonry Debris from Chimney Stack

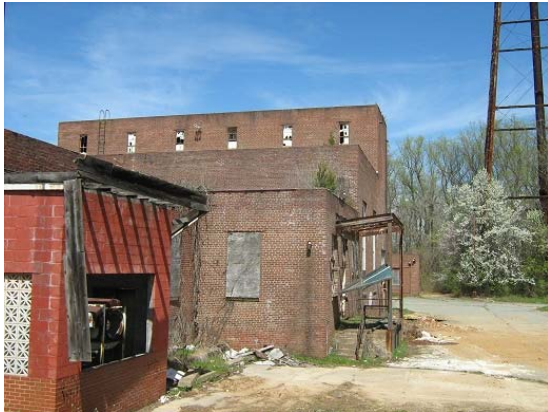
Figure 4.2- 83: SE Elevation - Laundry

The structure for this building appears to consist of a concrete slab supported on a structural steel frame. The condition of the structure is fair. Widespread corrosion of the structural steel beams, columns and girders is evident. Standing water is visible on the slab on grade.

2b	Laundry	If the waterproofing envelope of the building is restored, the growing vegetation on the façade is removed, the standing water is dried out, and proper humidity and ventilation limits are maintained, the structure of this building can be kept from further deteriorating for several years and the risk of façade damage will be low.
5 & 6	Apartments 1 and 2	To preserve the integrity of this structure, the roofs would need to be replaced very soon to prevent further damage and eventual partial collapse of the floors and facades. Without this work, the risk of façade damage is high.
9 & 10	East and West Duplexes	If the roof is repaired and the waterproofing envelope of the building is restored, the growing vegetation on the façade is removed, any standing water is dried out, and proper humidity and ventilation limits are maintained, the structure of these houses can be kept from further deteriorating for several years and the risk of façade damage will be low. We anticipate that considerable reframing of the wood floor framing will be required to make these structures safe again in the future.

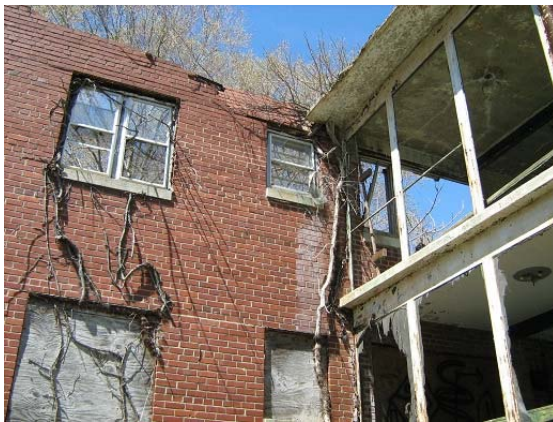
The structures for both these buildings are in bad condition due to the partial collapse of the roof. In a few areas, the perimeter façade is cracking and at risk of falling.

Figure 4.2- 95: Apartment 1 - Collapsed Roof/Facade Rear Roof Elevation

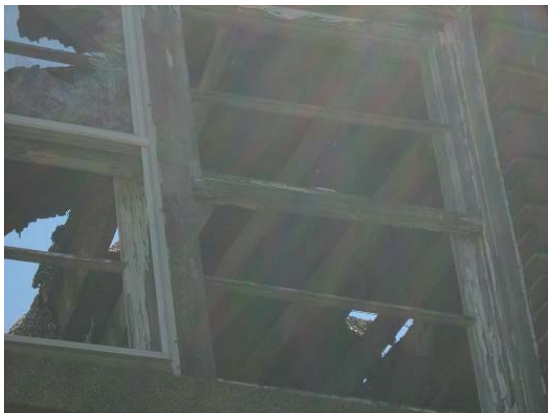
Figure 4.2- 97: Apartment 1 - Collapsed Roof

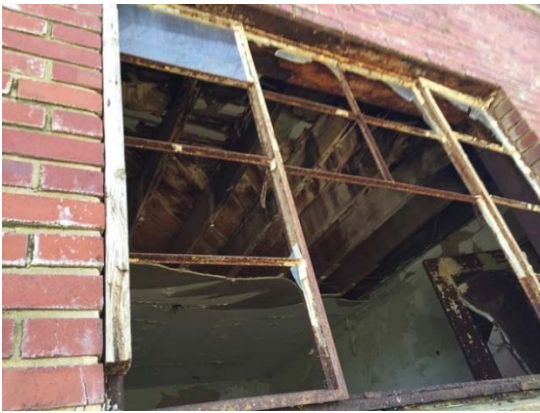
Figure 4.2- 98: Apartment 2 - Moisture in Floor Joists

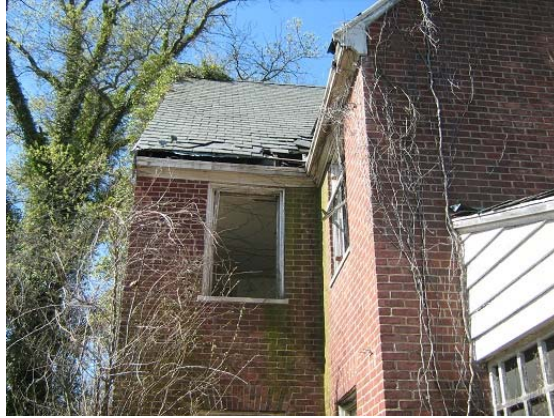
The structures for both these two small houses are in fair condition. The floor decking has areas where it has rotted, making any interior observations unsafe. Water damage is evident in portions of the roof.

Figure 4.2- 100: West Duplex Roof Damage

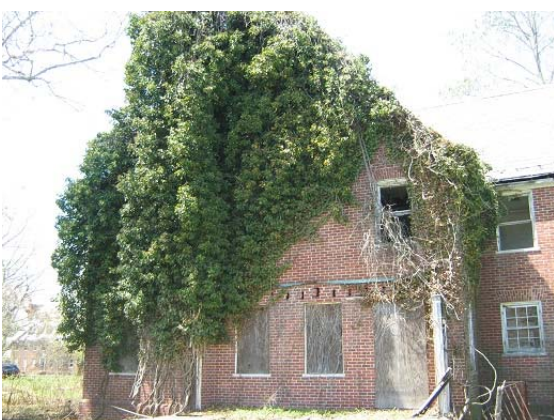
Figure 4.2- 102: East Duplex - Vegetation on Facade

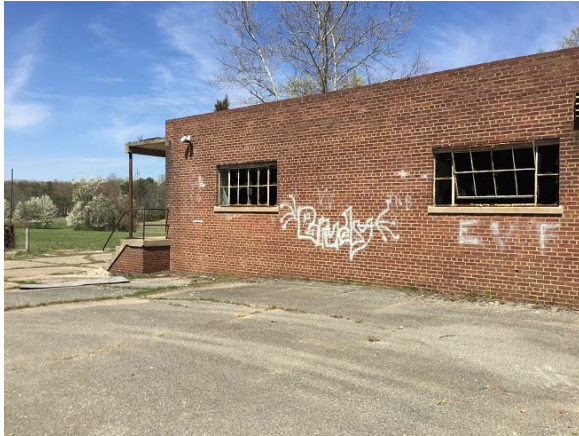
Figure 4.2- 107: Garage Street Elevation

The structure for this building appears to consist of a precast double-tee roof with precast beams and columns. The condition of the structure is good. Isolated areas of corrosion of the reinforcing bars in some beams and slabs are evident at random locations, but the extent of this damage does not appear to be widespread.

No significant structural damage was observed. Areas of standing water are visible at the floor.

1a & 1b	Warehouse and Garage	If the waterproofing envelope of the building is restored, the standing water is dried out, and proper humidity and ventilation limits are maintained, the structure of this building can be kept from deteriorating for several years and the risk of façade damage will be low.
3 & 4	Pump House and Water Softener House	To preserve the integrity of this structure, the roof would need to be replaced very soon to prevent further damage and eventual partial collapse of the floors and facades. Without this work, the risk of façade damage is high.
NO #	Well House	If the waterproofing envelope of the building is restored, any standing water is dried out and proper humidity and ventilation limits are maintained, that the structure of this building can be kept from deteriorating for several years and the risk of façade damage will be low.

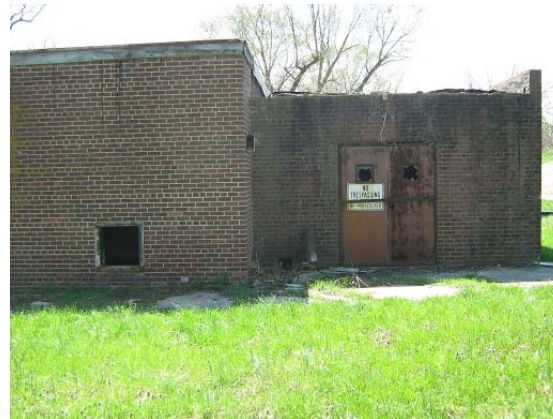
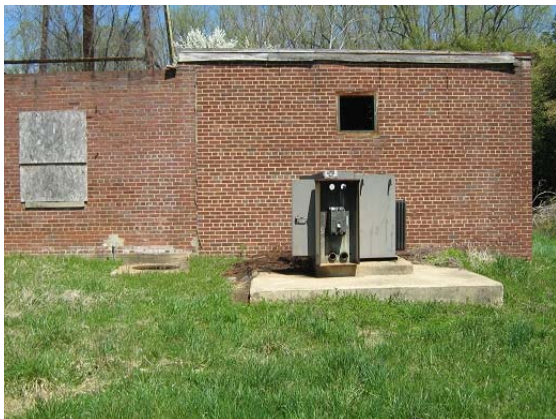
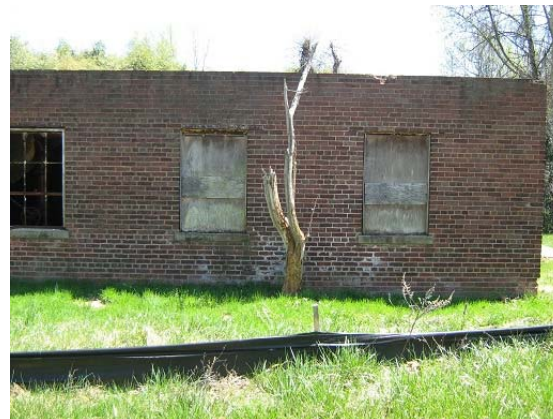
Figure 4.2- 116: Pump House - Front Elevation

Figure 4.2- 117: Pump House - Rear Elevation

Figure 4.2- 118: Pump House – Side Elevation

The structures for both these buildings are in bad condition due to the partial collapse of the roofs. In a few areas, the perimeter façade is cracking and at risk of falling.

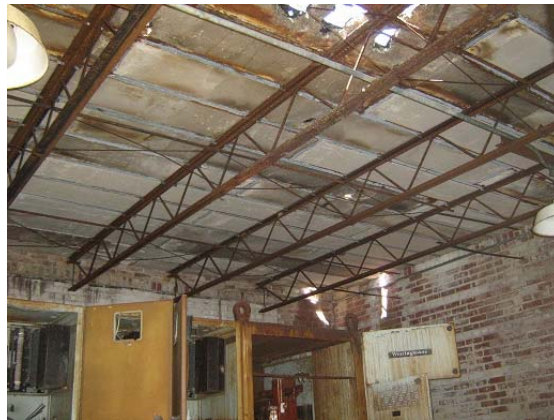
Figure 4.2- 122: Pump House - Roof Framing

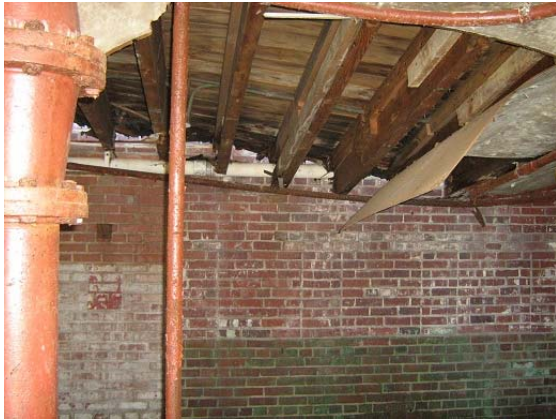
Figure 4.2- 123: Pump House - Collapsed Roof

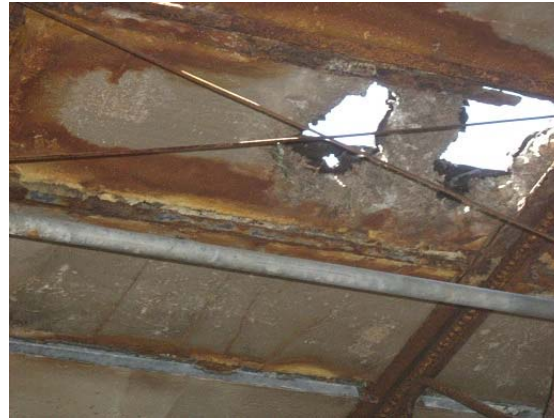
Figure 4.2- 124: Pump House - Holes in Roof

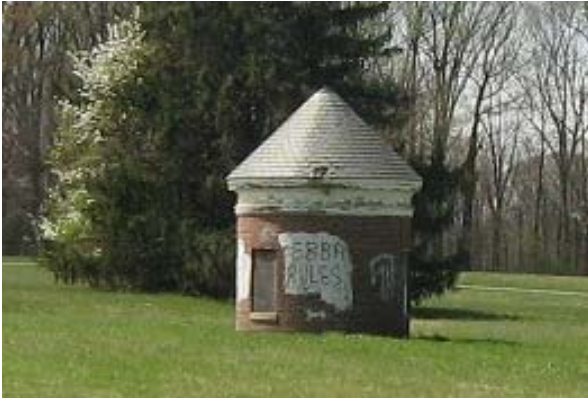
Figure 4.2- 125: Well House

We were not able to access this structure but from the exterior its condition appears to be good.

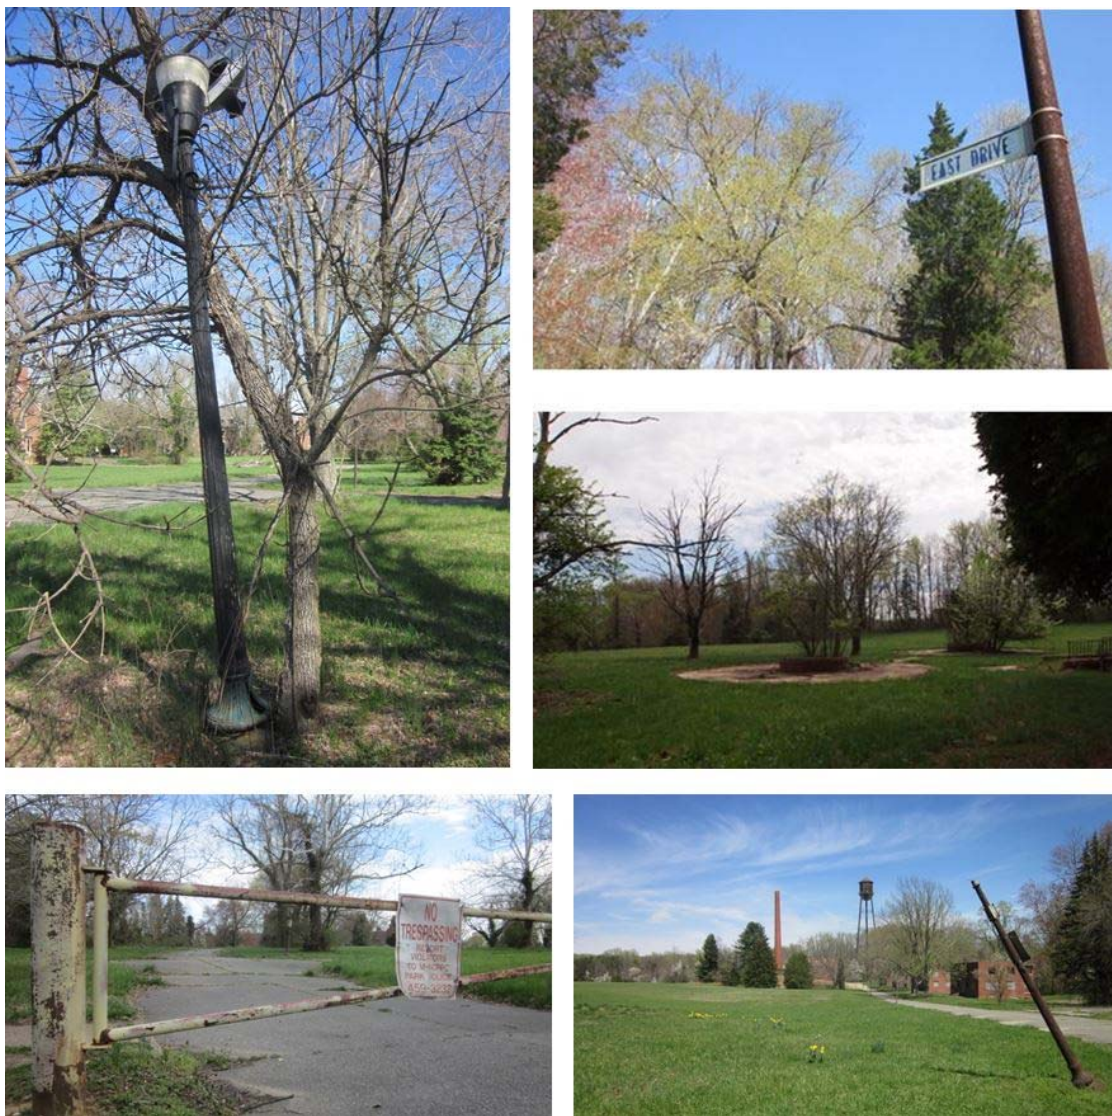
Some man-made features have also survived, including lamp posts, street signs, and gates, all in fair condition.

Figure 4.3- 1 Landscape features at the Glenn Dale Hospital Historic District.

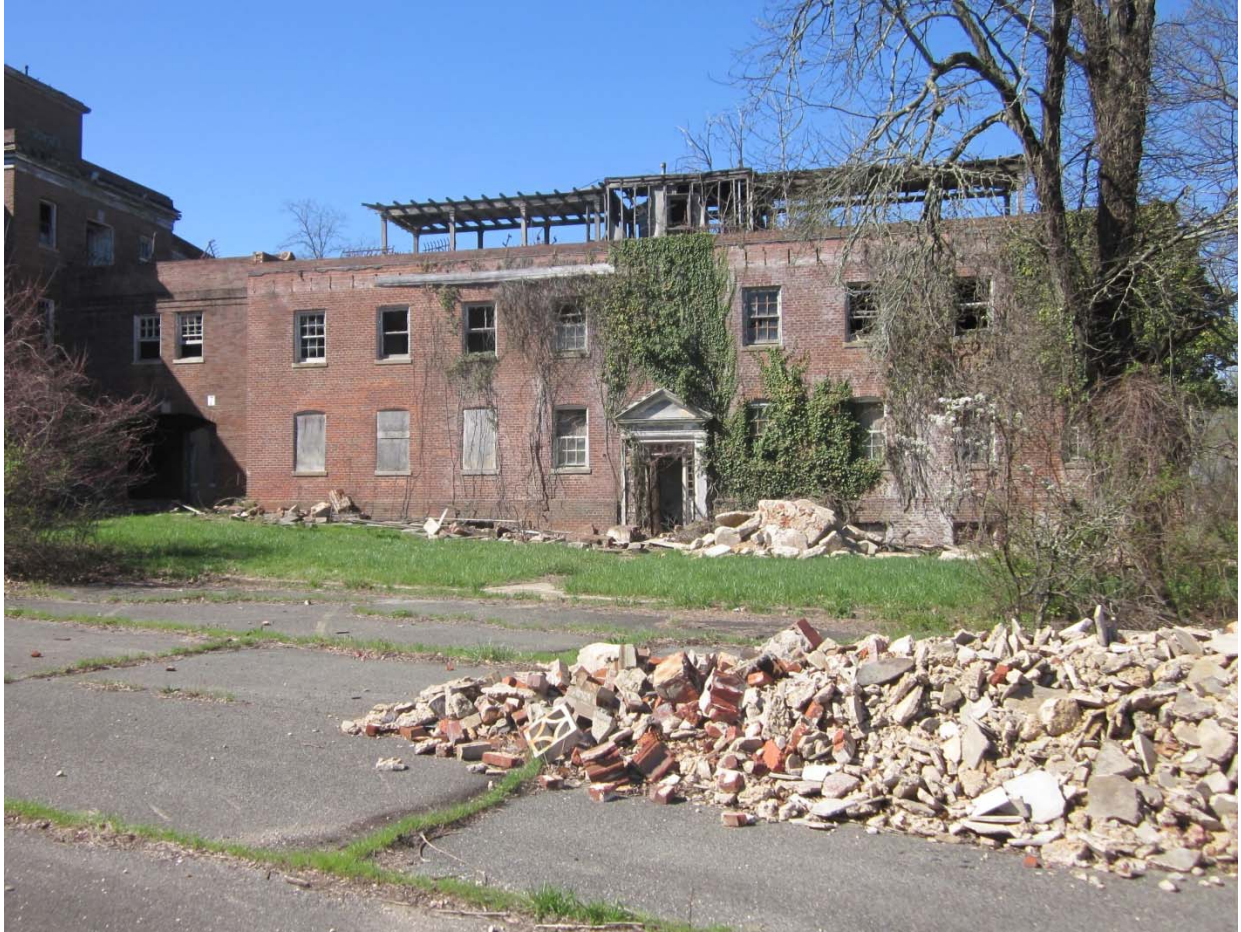
Figure 5.5- 2 Debris outside of Gibson Hall.
